# **Report on Study of Electrical Component Corrosion Related to Problem Drywall**

U.S. Consumer Product Safety Commission

March 2011

## **Report on Accelerated Corrosion Studies of Electrical Components**

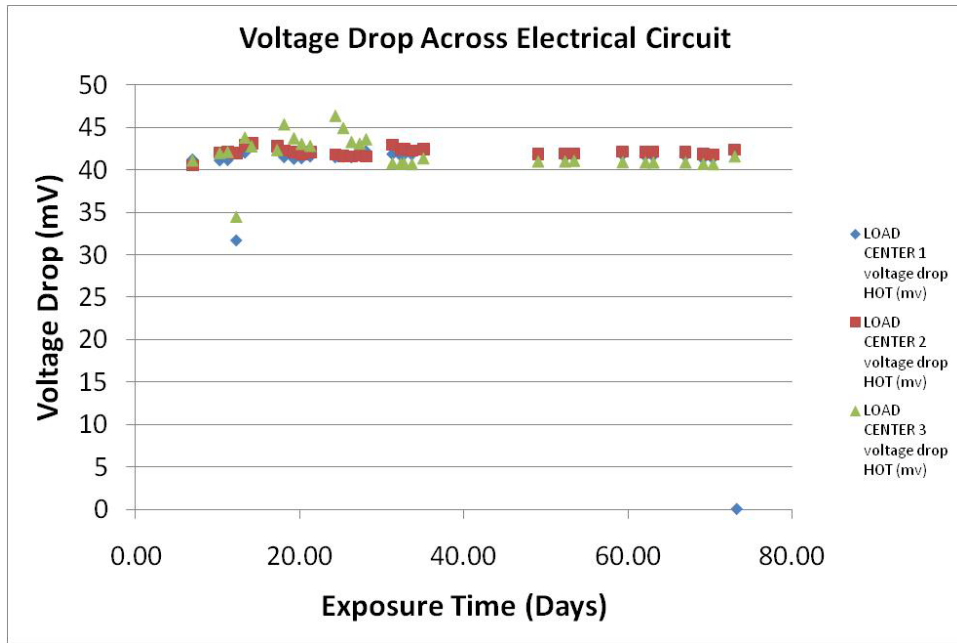
To determine if corrosion products on contacts could lead to resistive heating, measurement points were established to allow the voltage drop across the entire electrical circuit to be measured. Measurements were made several times a week and were taken while the circuit was activated under a 12 A load. Measurements were made with a Keithley 2000 multimeter. Dedicated test points were wired into the circuit (external to the exposure chamber) to allow measurement on a regular basis. Voltage drop data are shown in Figure 8 (hot leg) and Figure 9 (neutral leg). All three of the circuits exhibited essentially identical behavior. The hot leg of the circuit registered about 40 milli-volts and remained constant throughout the test. The neutral leg of the circuit registered about 25 milli-volts and remained constant. The difference is due likely to the smaller number of components with neutral wire connections (both switches and the standard circuit breaker used only hot wire connections). The small magnitude of the voltage drop suggests that resistive heating—due to the presence of corrosion products—should not be a concern.

Figure 8. Voltage measurements made along the length of the ungrounded conductor (hot leg) for each of the three circuits, which included the load center and all the electrical components.

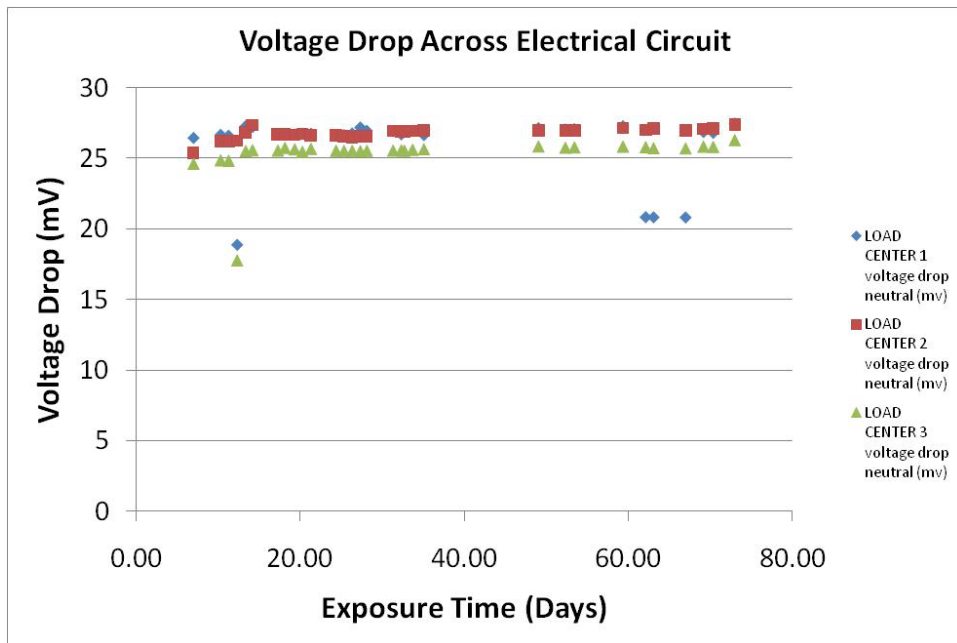
Figure 9. Voltage measurements made along the length of the grounded conductor (neutral leg) for each of the three circuits. Circuits included the load center and all of the electrical components.

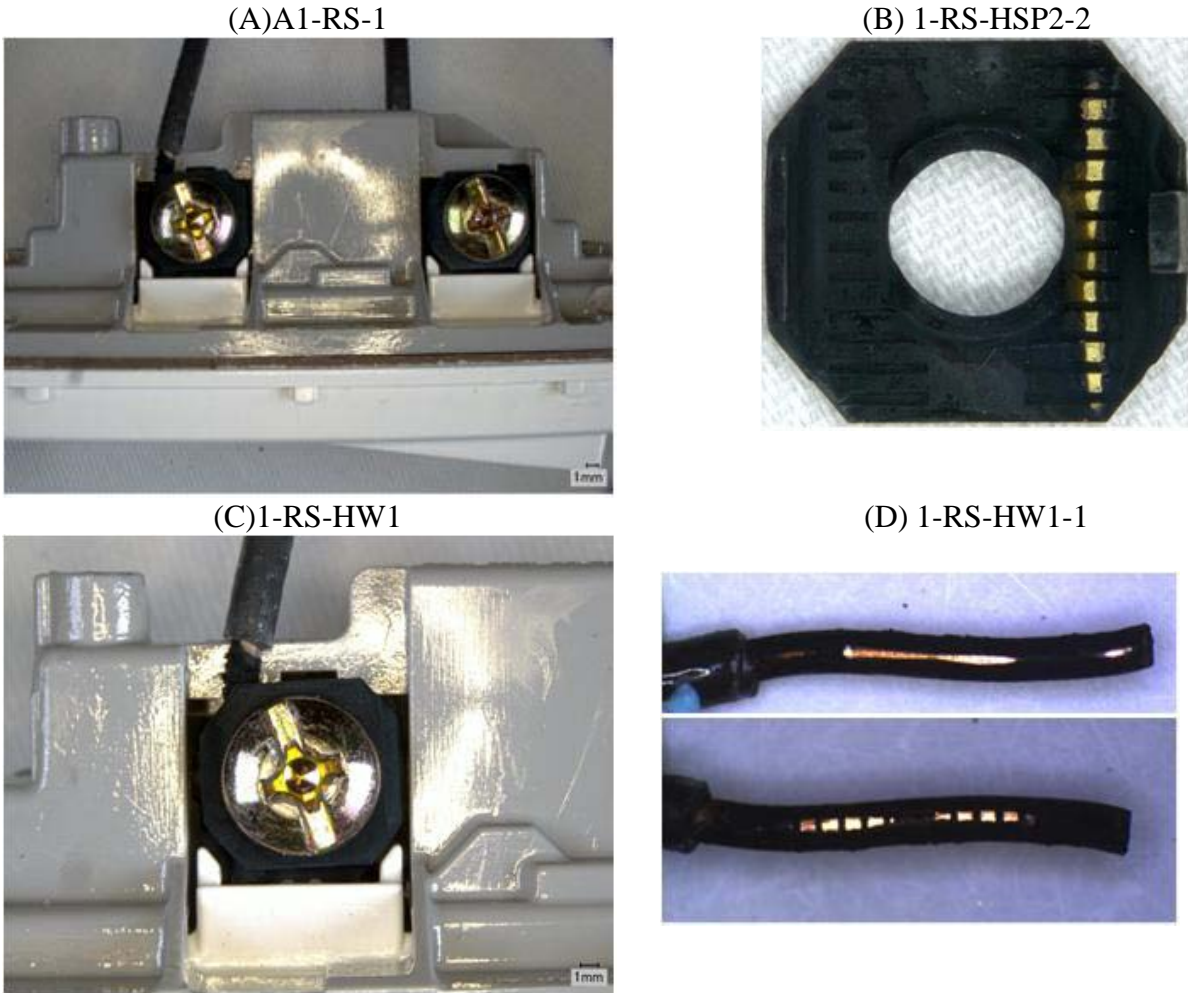
Figure 11 shows macro images for the rocker switch. The image in (A) shows one set of electrical connections to the switch. The image in (B) is of the contact plate under one of the screws. The image in (C) shows a close-up of one of the connections, and (D) shows both sides of the hot wire that was connected to the switch. The black color of the metal parts is the result of the sulfidation process. The contact plate is tarnished completely. Importantly, a row of shiny contact points is visible where the wire contacted the plate. There is a corresponding set of similar features on the wire, where the wire was in intimate contact with the screw. Note that bare metal is visible, indicating that the interface was shielded from the active species in the gas. The screws exhibit less attack. The wire shows considerable corrosion, with “furry” growth observed next to the insulation. Additionally, there is a band of bare metal adjacent to the insulation that appears to have suffered less attack. That is likely the result of slight movement of the wire, exposing fresh surface that had been protected previously by the insulation. This does point out the fact that the insulation shields the underlying metal from exposure to the gas. However, it is also important to note that this accelerated test is designed for boldly exposed metals. It is not designed to accelerate transport of aggressive species through the insulation. Thus, it does not represent 40 years relative to sulfide diffusion and cannot be used to assess the ability of the insulation to protect the wire over a 40-year life.

Figure 11. Optical images from sample 1-RS (rocker switch). The contact plate is shown in B, and one of the hot wires is shown in D (both sides of the same wire are shown). Note the presence of extensive corrosion product on the copper hot wire and contact plate.

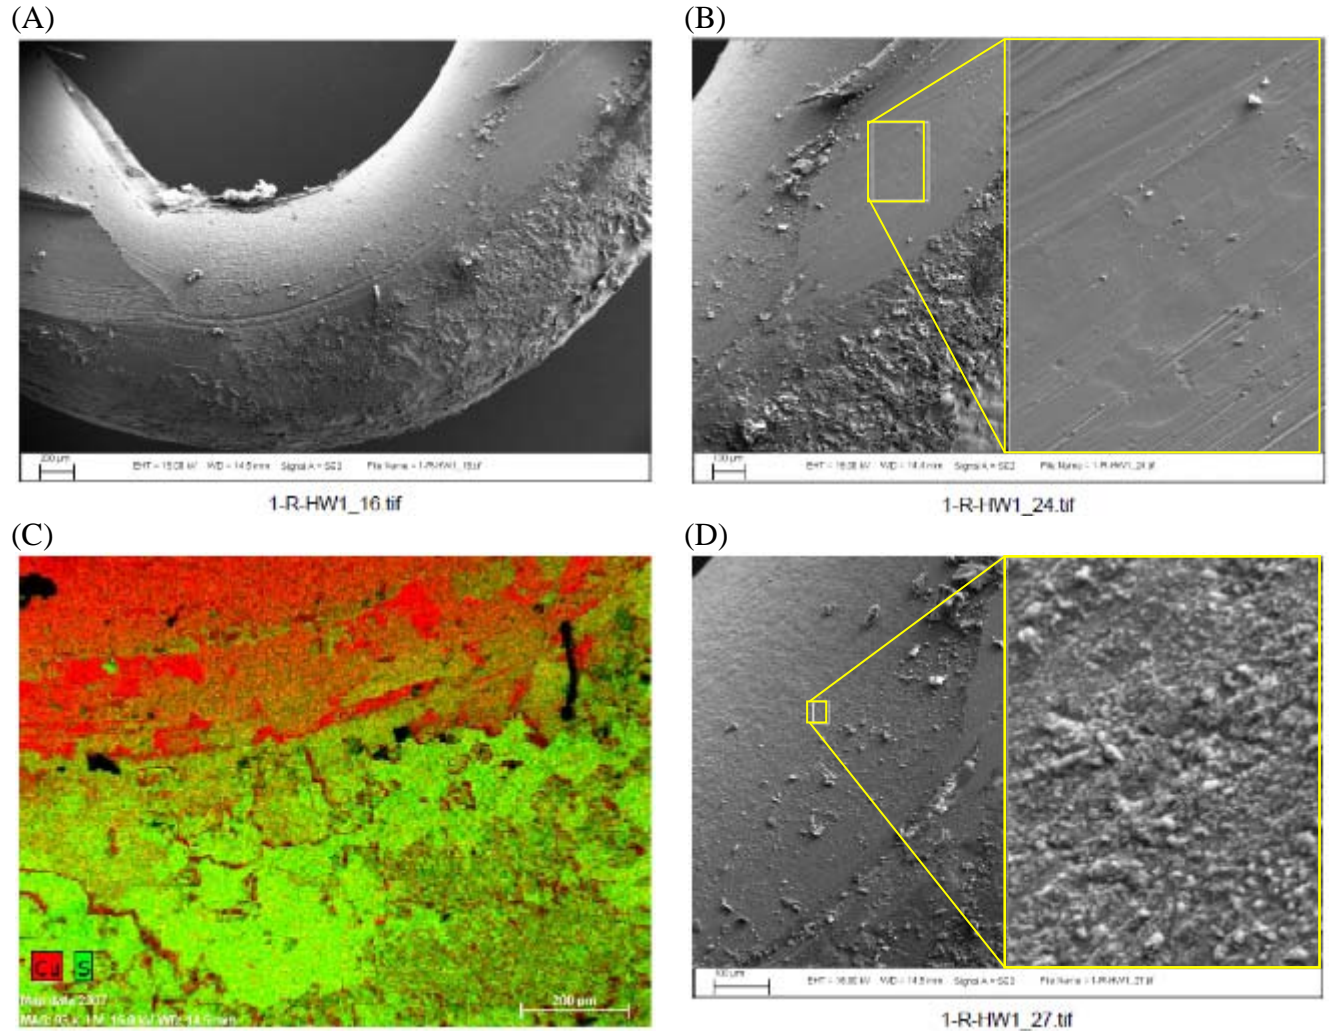
SEM analyses of the hot wire are shown in Figure 21. The location of these analyses is the bend in the wire. Note that the corrosion is significantly more extensive on the outside of the bend. The elemental maps clearly show the difference in corrosion product thickness, clearly a result of shielding the inner portion of the bend from the corrosive gasses.

Figure 21. SEM image (A) of hot wire 1-R-HW1; (B) SEM image of screw contact surface with zoomed area (top right); (C) EDS elemental map showing copper (red) and sulfur (green) distribution; and (D) SEM image ~300  $\mu\text{m}$  from contact (all with 100  $\mu\text{m}$  measurement bars).

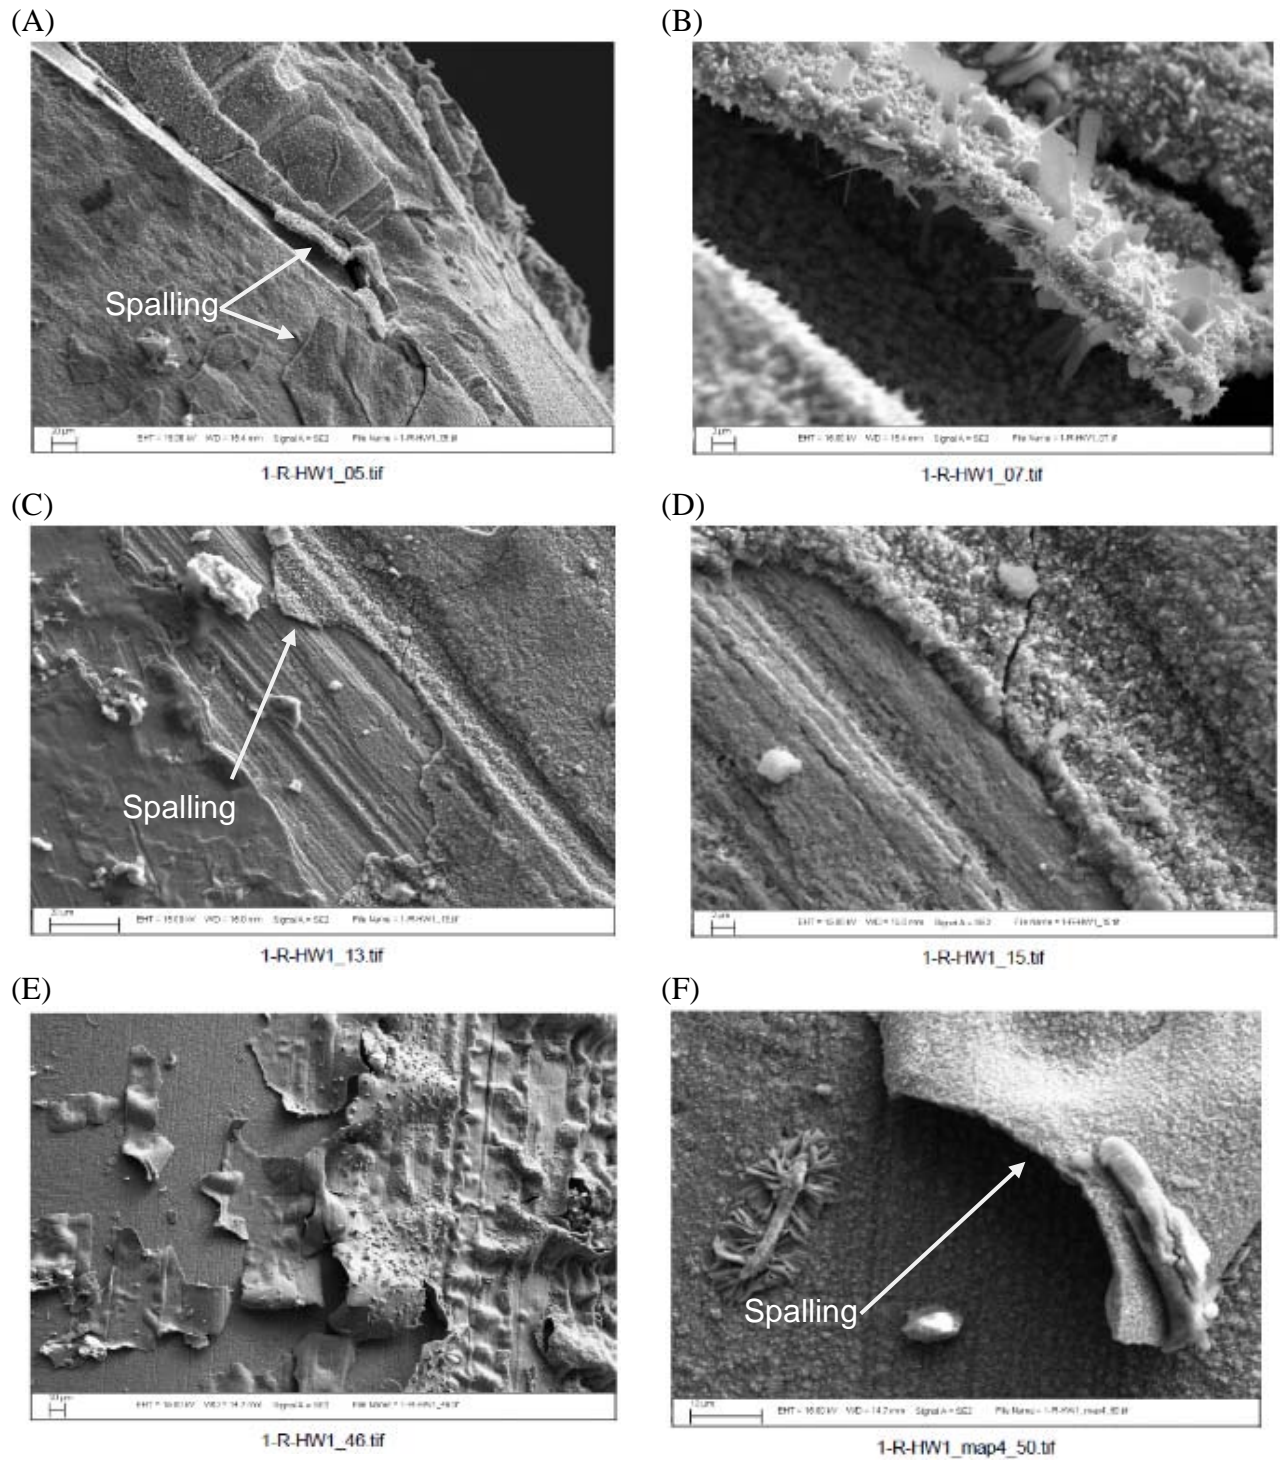
Figure 22 presents SEM images from various locations on the hot wire. Several corrosion product morphologies can be seen. In addition, there is evidence of spalling of the film. Once the film ruptures, it reforms below the previous layer.

Figure 22. SEM images showing the different morphologies of corrosion products on the hot wire from the receptacle in Circuit 1.

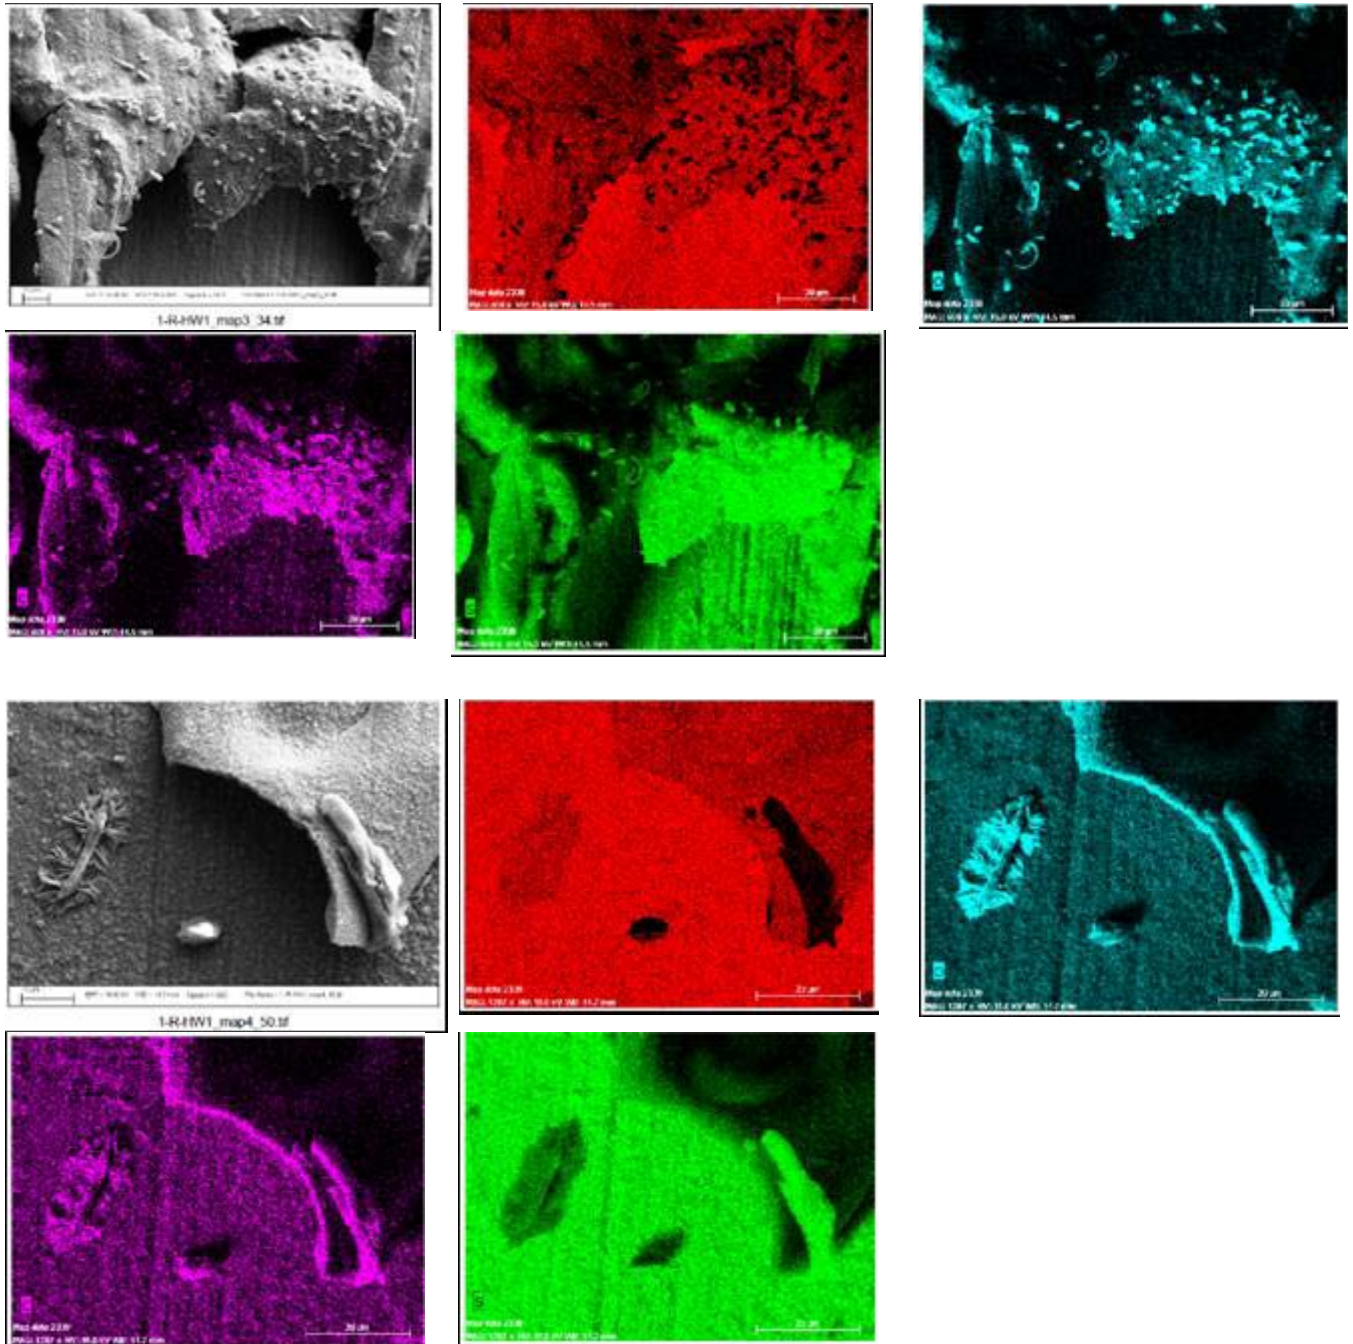
In addition to differences in film morphology across the surface, there is also evidence of differences in film composition. An example is shown in Figure 23. Clearly, certain features are oxygen rich, while others are sulfur-rich. The oxygen-rich features are on the outer surface of the film, and are likely due to oxidation of the surface of the copper sulfide.

Figure 23. SEM images and elemental maps for two areas on wire 1-R-HW-1, showing copper (red), oxygen (blue), carbon (purple), and sulfur (green) distributions.

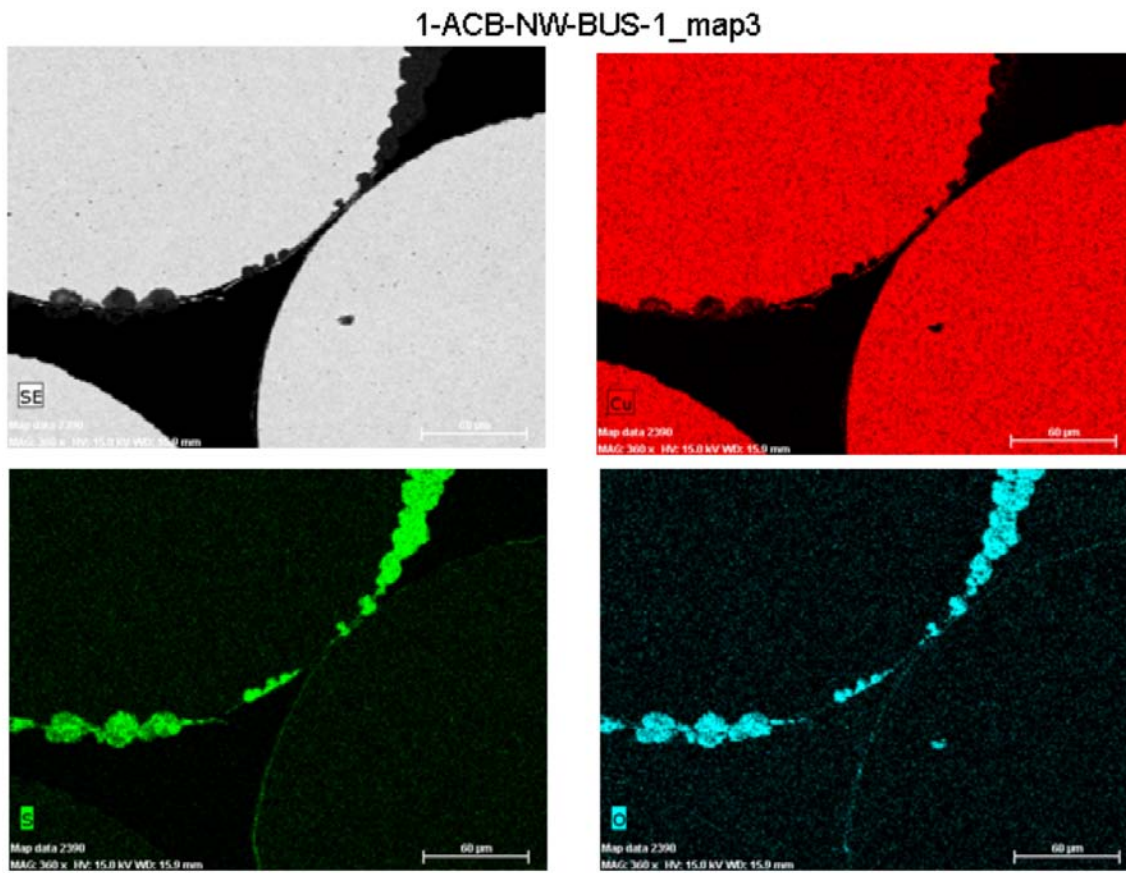
Figure 28 shows elemental maps taken on the stranded wire from the AFCI that was attached to the load center bus. All of the strands of wire are covered with a sulfide layer.

Figure 28. Elemental maps taken on cross section of the neutral wire from the arc-fault circuit breaker from Circuit 1. The image on the left is an SEM image of the area being analyzed. The elemental maps for Cu (red), S (green), and oxygen (blue) are shown.

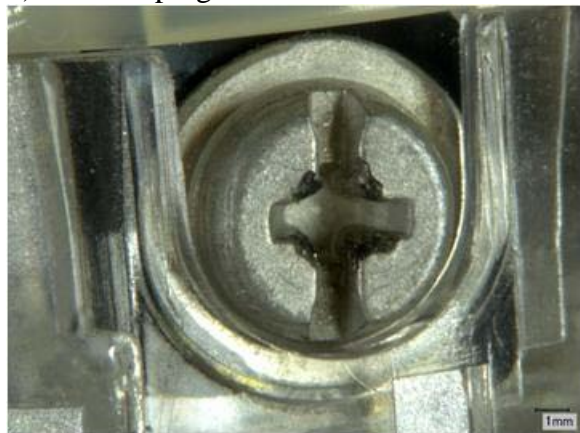
Figure 30. Optical images of the plug used to connect the standard receptacle to the GFCI receptacle in Circuit 1. The prongs and screws are blackened relative to those on a new, as-received, unexposed plug.

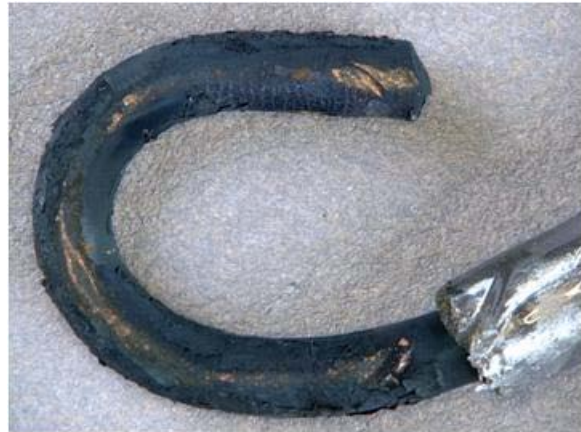
Figure 43. Optical images of the toggle switch in Circuit 3. The figure on the left shows the inside of the switch. Note the extensive corrosion product on some of the components. The image on the right is of the hot wire connected to the toggle switch (screw side).

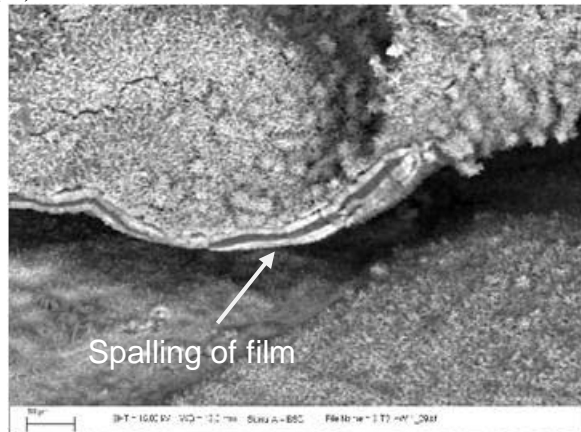
Figure 44. SEM images of the hot wire from the toggle switch in Circuit 3. Note the spalling of the corrosion product film. The contact areas can be seen in the upper two images (bright areas) where the contact shielded the surface from the corrosive gasses.

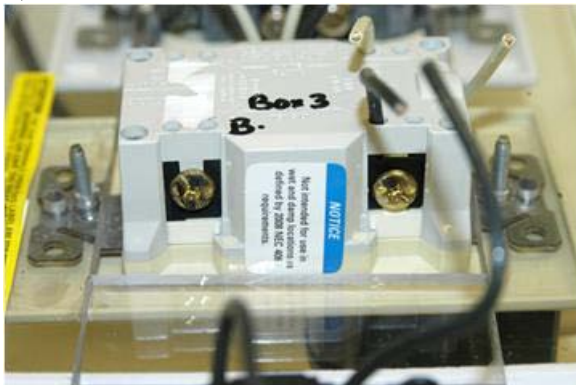
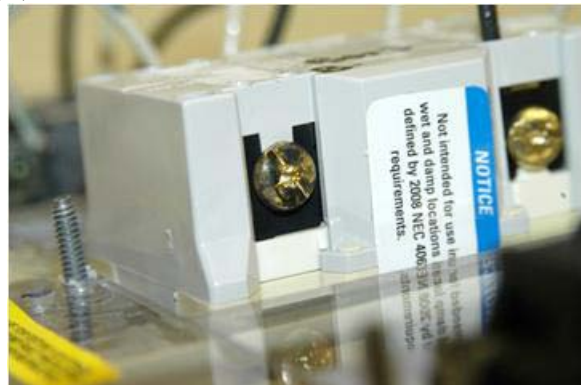
Figure 52. Optical images of the GFCI receptacle. Note the darkening of the normally shiny contact pads and slight corrosion (discoloration) of the screws.

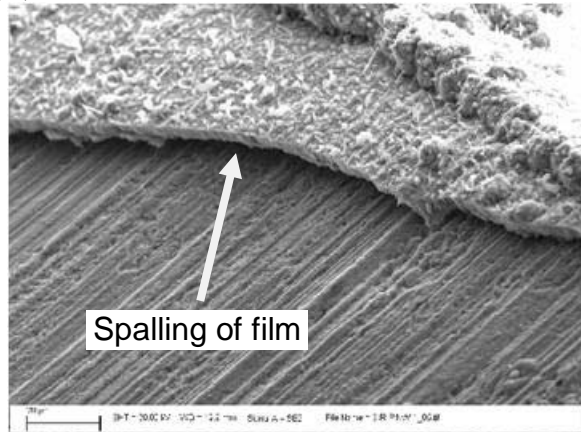
Figure 54. SEM images of the surface of the neutral wire from the receptacle in Circuit 3. The connection was a push-in connection. (B) shows the contact point, which is brighter due to the presence of Cu without S. The end of the wire is shown in the lower images at two magnifications. Note the spalling of the corrosion product film. It is believed that the spalling occurred during the test, but is it possible that it occurred after exposure and prior to analysis.

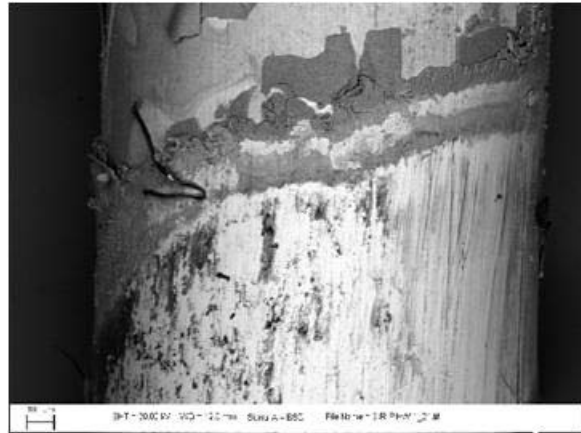
Figure 59. SEM images of the hot wire from the receptacle in Circuit 3. The connection was a push-in connection. The contact point is shown in the image on the left. The image on the right shows a region of a hot wire that was covered by insulation on the bottom.
