# **Report on Study of Electrical Component Corrosion Related to Problem Drywall**

U.S. Consumer Product Safety Commission

March 2011

## **Report on Accelerated Corrosion Studies of Electrical Components**

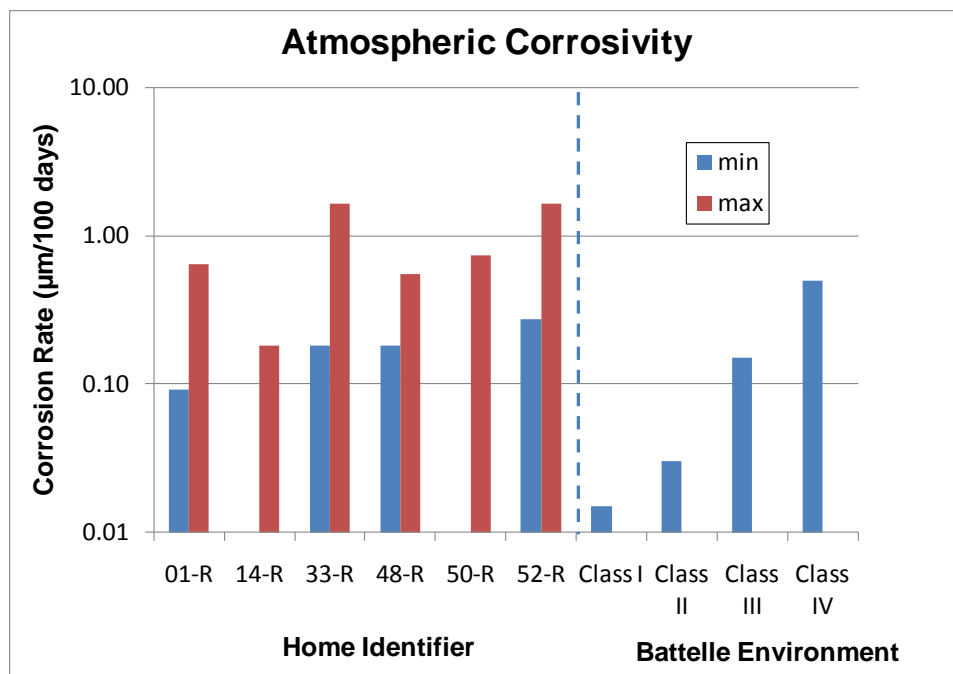
This experiment was designed to test multiple components of a powered electrical system in an environmental chamber in which Battelle Class IV conditions were maintained. The selection of the Class IV environment was based on results from components harvested from several homes. The components were analyzed, and a corrosion product thickness was determined. The exposure was estimated to be three years. Figure 1 presents the data from the harvested components and compares the result to published mixed flowing gas testing. Based on these data, the best fit corrosion class appears to be Class IV, the most extreme corrosive conditions of the Battelle exposure system.

Figure 1. Data from components harvested from homes used to determine the appropriate corrosion class for testing. The data are compared with results from Battelle Class I through Class IV.

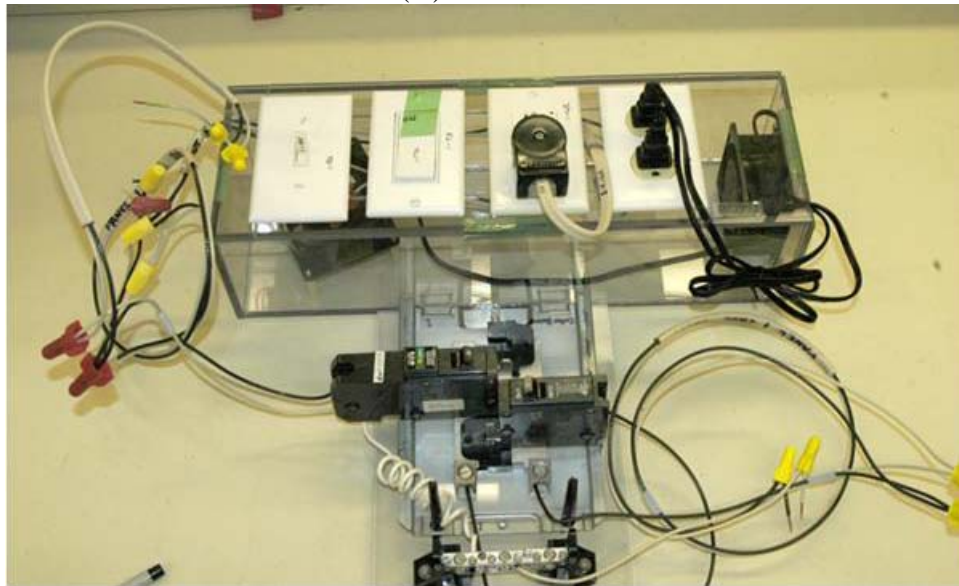
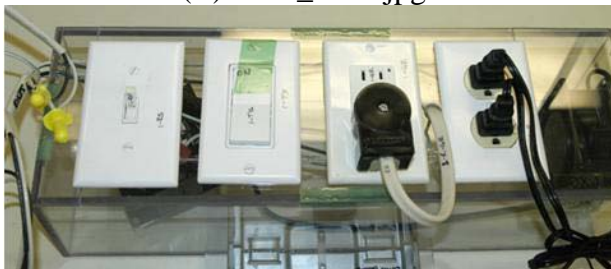
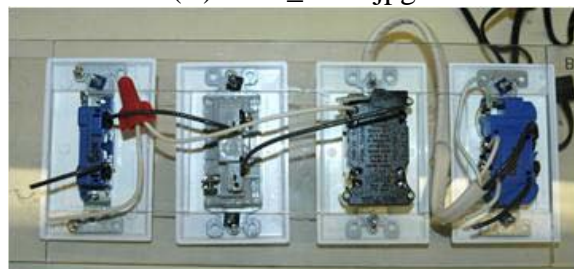
Figure 10 shows the components for Circuit 1 prior to disassembly. Once they were removed from the box and examined, several of the parts were selected for various analyses. Table 4 presents the individual components and associated analyses for Circuit 1.

Figure 10. Photographs of the electrical components tested in Circuit 1. The view from the bottom (C) shows how the system was wired electrically.

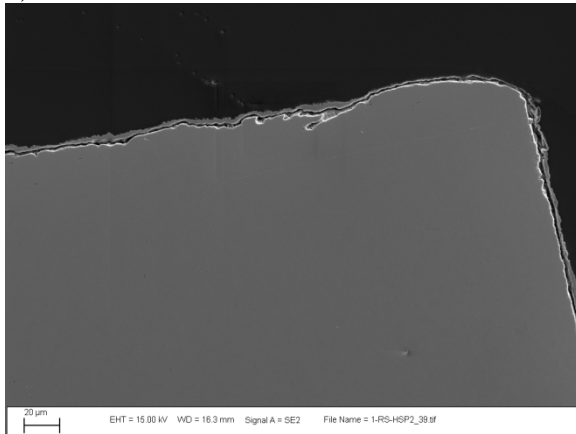
(A) 1-RS-HSP2-39

<b>Part</b>	<b>Figure Number</b>	<b>Comments</b>	<b>Thickness (microns)</b>
1-RS-HSP2	Figure 12, Figure 13	Void below corrosion film. Measure depth from perpendicular	15.3
1-RS-HSP2	Not shown		12
1-RS-HSP2	Not shown	At inside curvature of part	36.6
1-RS-HSP2	Not shown	Separation of outer layer, possible fill underneath	52
1-RS-HSP2	Not shown	Wide view with layers and pits	25

Figure 12 shows SEM images of a cross section of the hot screw plate from the rocker switch. Figure 13 and 14 present the elemental data obtained from EDS analysis of the cross section shown in Figure 12. In Figure 13A, a thin layer of corrosion product is visible on the surface of the contact plate. There is evidence of voids below the corrosion product layer, consistent with the sulfidation process. The elemental maps also show Cu and Zn (Figure 13C-D), elemental constituents of the substrate (brass). The sulfide layer is clearly visible on the surface. As seen in Figure 14, the corrosion product layer also contains chlorine and oxygen.

Figure 12. SEM cross section of the hot screw plate (HSP2) from the rocker switch in Circuit No. 1.

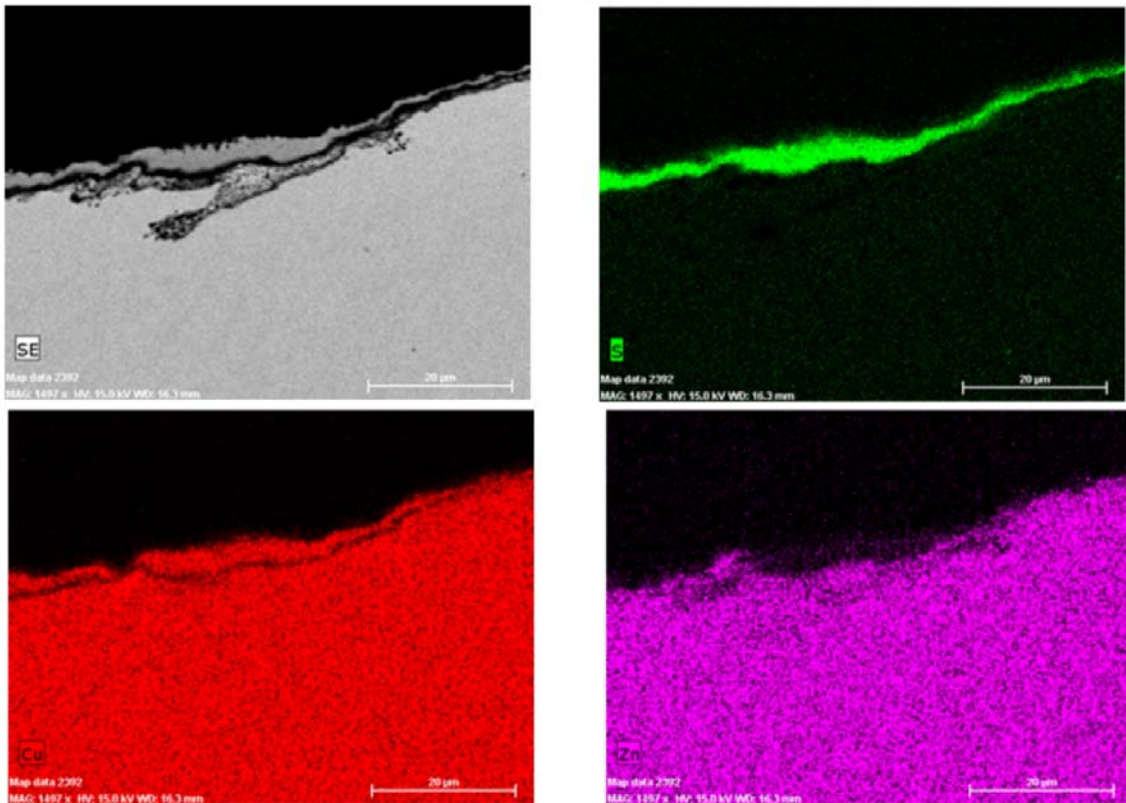
1-RS-HSP2\_map1

Figure 13. SEM image (top left) and elemental maps using EDS of HSP2: sulfur (green), Cu (red), and Zn (purple).

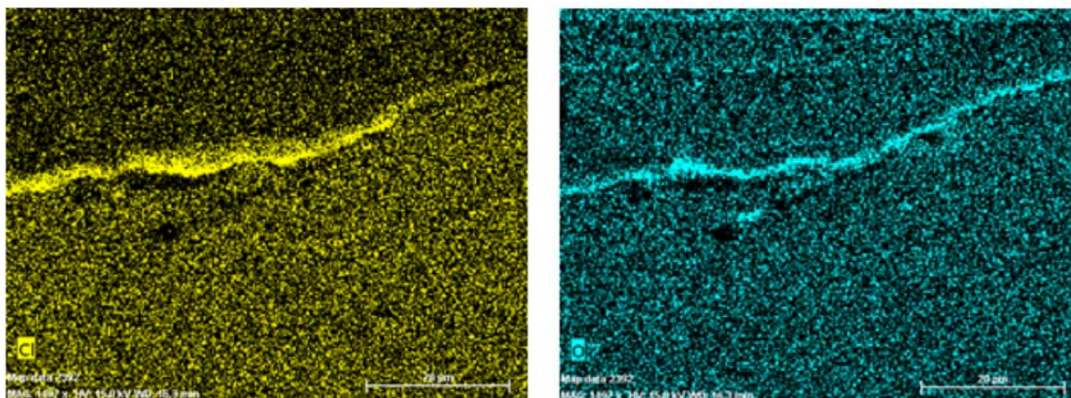
Figure 14. Elemental maps using EDS of HSP2, showing chloride (yellow), and oxygen (blue).

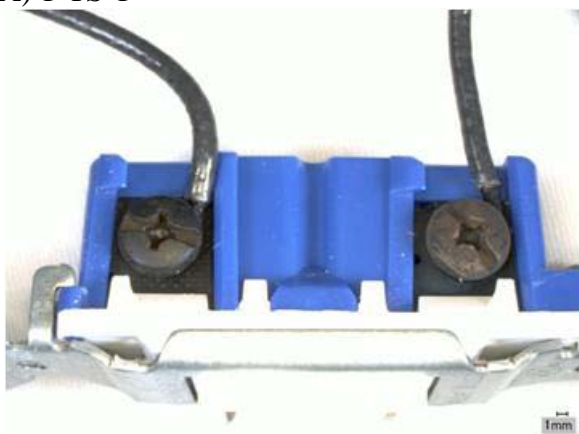
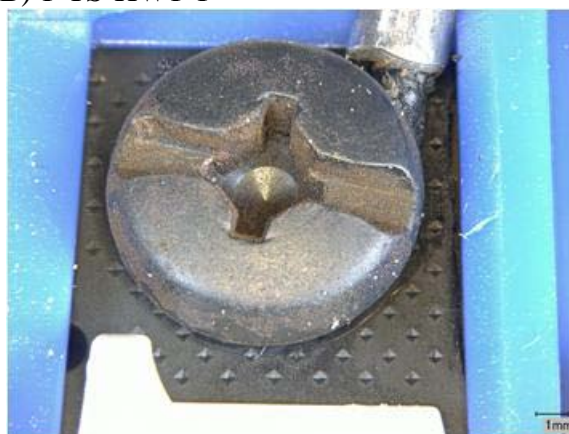
Figure 15 shows optical images of the toggle switch from Circuit 1. The metal contact surfaces exhibit sulfidation. Tarnishing of the wires, contact plates, and screws was observed.

Figure 15. Photographs of toggle switch from Circuit 1.

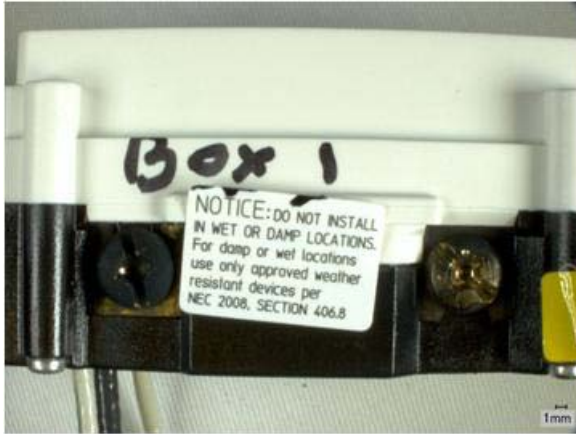
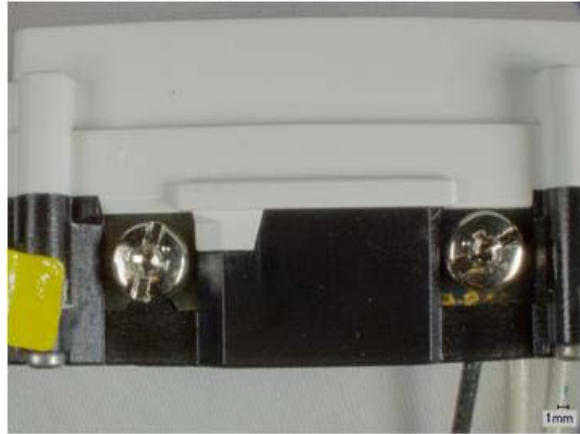
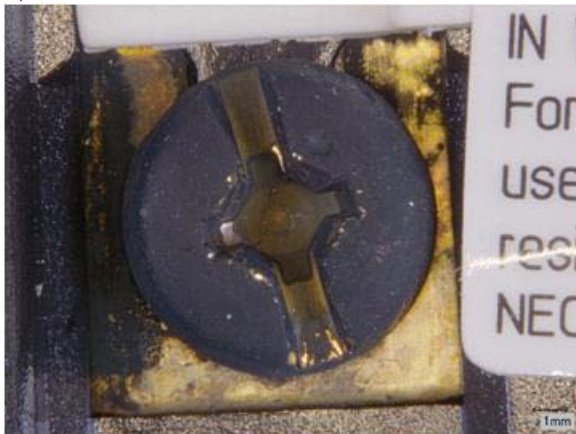
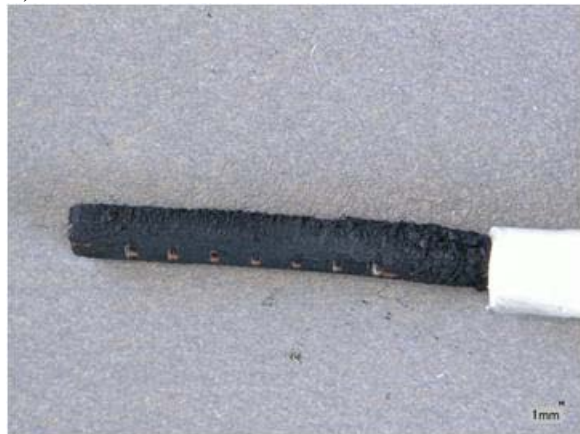
Optical images of the GFCI receptacle from Circuit 1 are given in Figure 16 and Figure 17. Corrosion of the contact surfaces was observed. The screws presented in (B) do not exhibit significant attack. Their color indicates that they are not brass screws, so they are considerably more resistant to sulfidation. Interestingly, the push-in wire (D) exhibits the presence of an extensive layer of corrosion product. This indicates that the gas permeated the receptacle itself. This is supported by the images in Figure 17, which show the insides of the GFCI. Clearly, the receptacle case presents little or no impediment to the corrosion gas. It is interesting to note that many of the internal components were corroded during this test (Figure 17D). Note that the majority of the contact is tarnished, with the real contact area (the spot near the center) exhibiting considerably less corrosion. During the test, one of the load lamps arced, resulting in tripping of

Figure 16. Photos of outside of GFCI receptacle from Circuit 1.

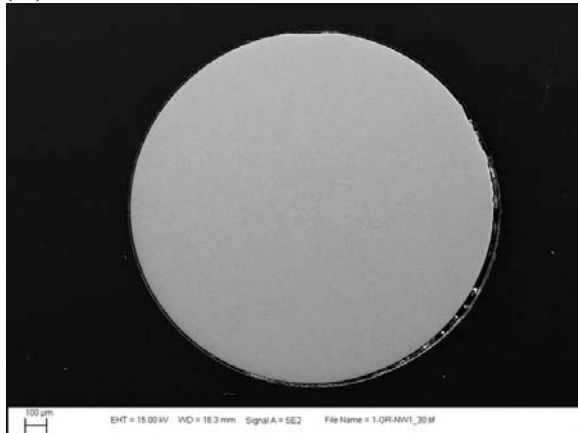
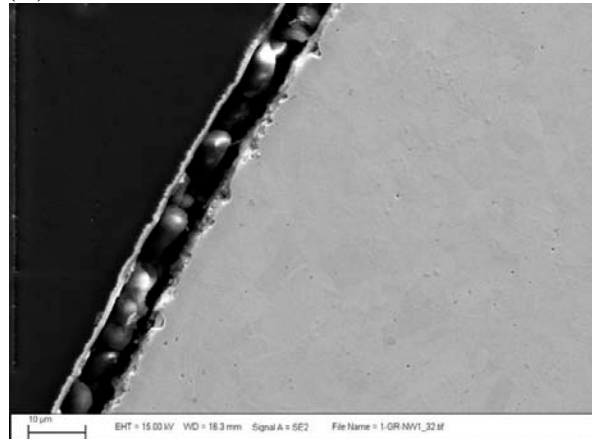
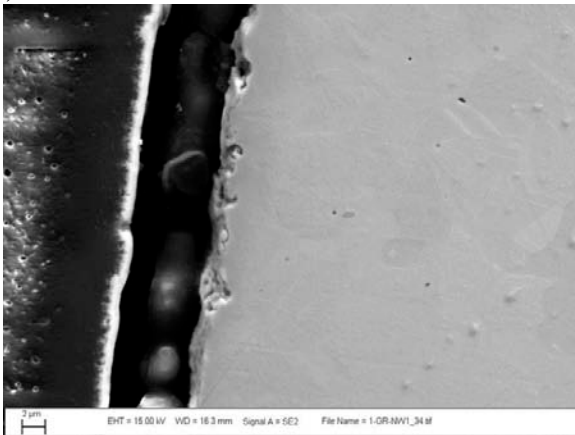
The neutral wire from the GFCI receptacle was cross sectioned for analysis. The SEM images are shown in Figure 18. A thin corrosion product layer can be seen covering the wire surface. A very conservative estimate of the decrease in cross section of the wire can be calculated based on the SEM images. As given in Table 2, the corrosion product thickness was 11 microns. If we assume that the thickness is uniform, and that the corrosion product thickness equals the loss of metal, the cross sectional area of the wire at the conclusion of the test is 98% of the original cross section. In reality, the area decrease is considerably less (the corrosion product thickness is less than the thickness of lost). Thus, attack of the wire did not result in a significant decrease in cross sectional area and does not affect the current carrying capabilities of the wire.

Figure 18. SEM images of cross section of neutral wire 1-GR-NW1.

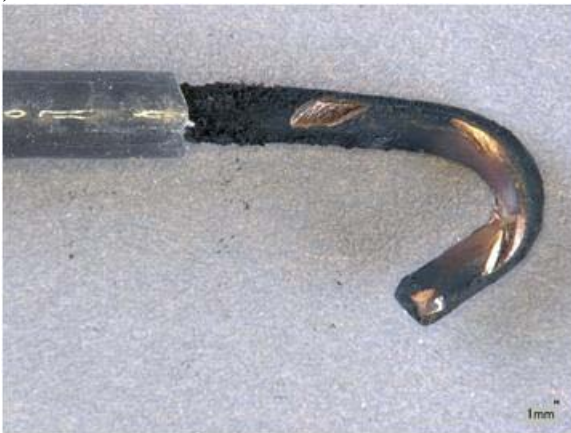
(A) 1-R-HW1-1

Analysis of the receptacle from Circuit 1 included optical images and SEM analysis of the hot wire. Optical images are presented in Figure 19 and Figure 20. They show corrosion of the Cu base materials. Very little attack of the neutral screws or the ground screw was observed. The wires exhibited significant attack, but were essentially untouched in two locations: where the wire was in intimate contact with screws, and where the wire contacted the pressure plate.

Figure 20. Optical photographs of hot wire removed from receptacle from Circuit 1.

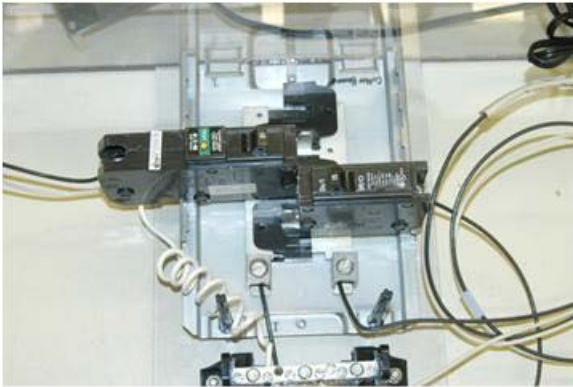
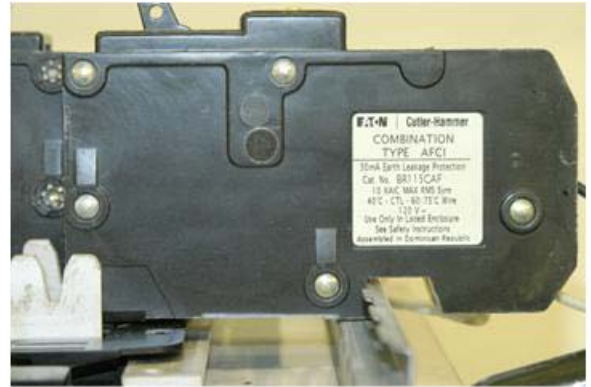
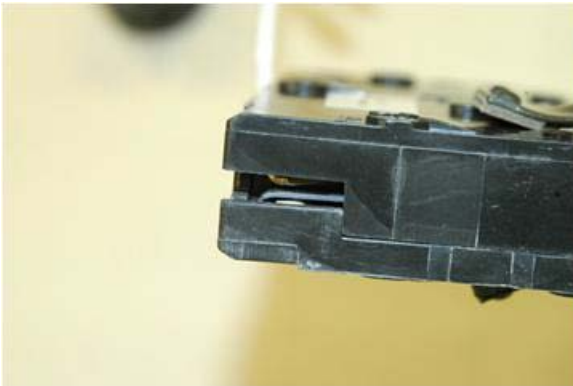
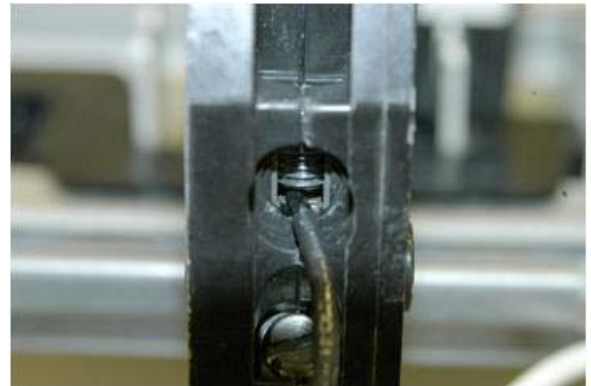
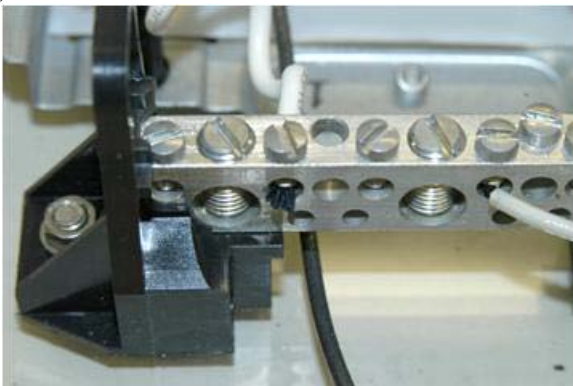
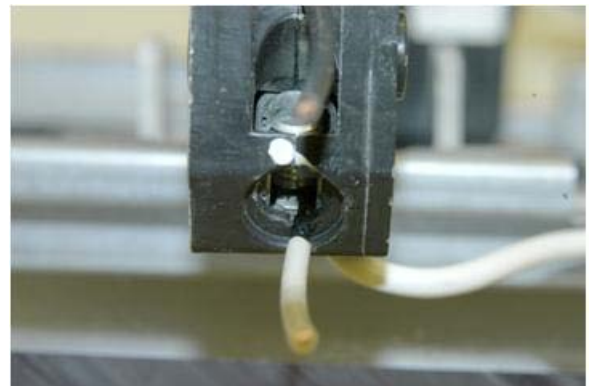
Figure 24 shows optical images of the AFCI from Circuit 1. The output from the standard circuit breaker provides the input to the AFCI. In addition, the neutral feed is connected to the neutral input, and the neutral sense wire is connected to the load center bus. Sulfidation of the contact surfaces can be seen. Both the neutral and hot wires exhibit corrosion, as well as the stranded neutral sense wire (where it is connected to the load center bus—lower left image).

Figure 24. Optical images of the load center and AFCI for Circuit 1.

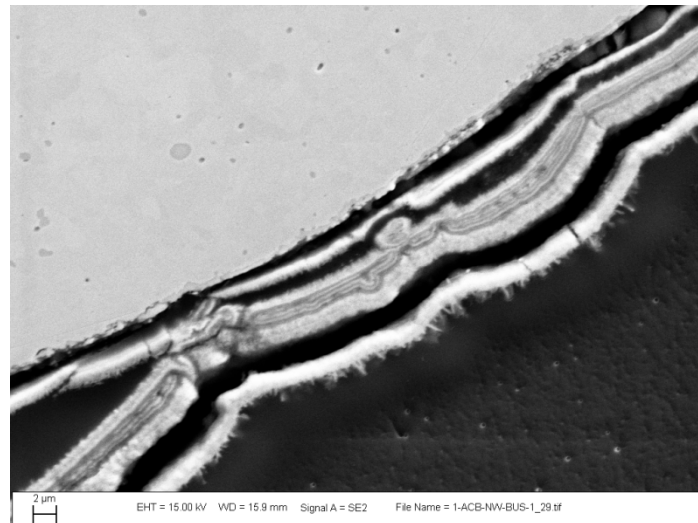
Figure 25 presents SEM images of the cross section of the neutral wire. A multilayered structure is observed. There is little or no adhesion between some of the layers, suggesting that spalling and/or delamination of the individual layers occurred during the corrosion process.

Figure 25. SEM image of the cross section of the neutral wire from the arc-fault circuit breaker from Circuit 1.

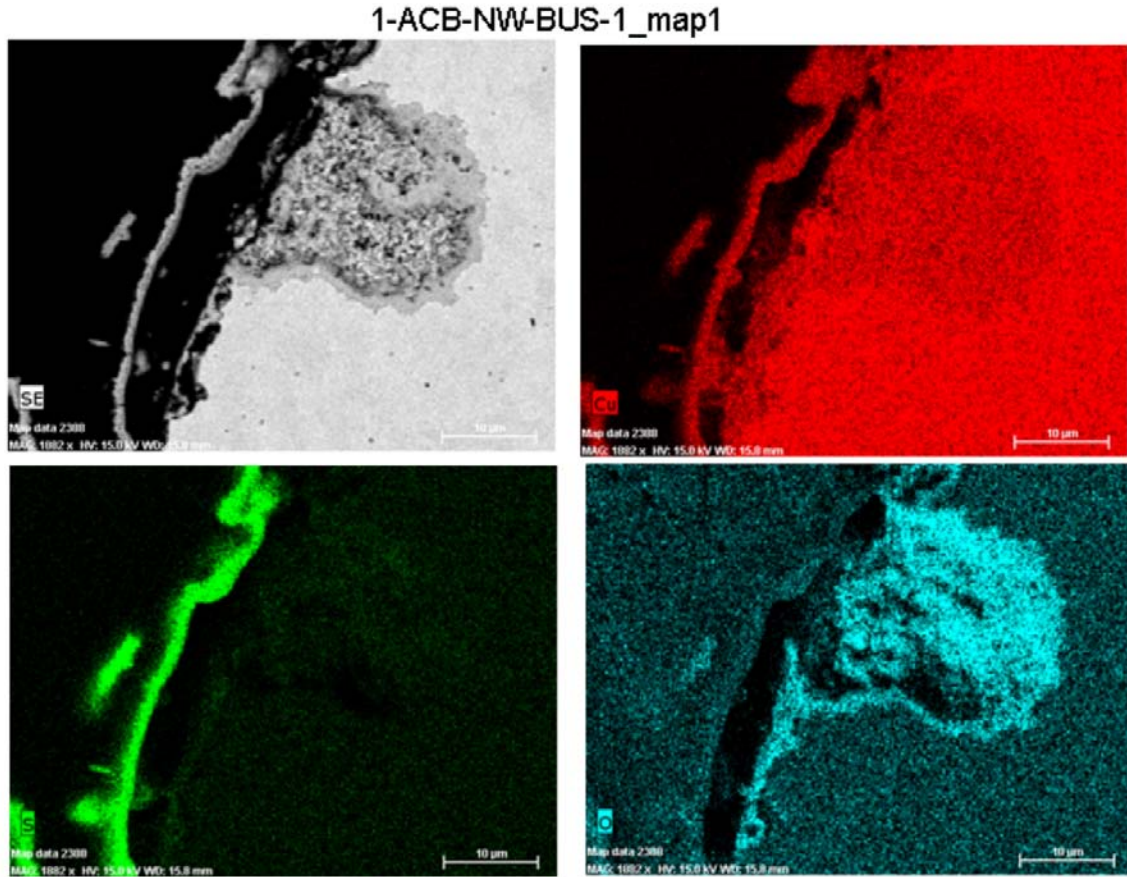
<b>Part</b>	<b>Figure Number</b>	<b>Comments</b>	<b>Thickness (microns)</b>
1-ACB-NW-BUS-1	Figure 26	Stranded wire Large pit	26.7
1-ACB-NW-BUS-1	Not shown	Stranded wire Flaked off layer + tight layer	6.3
1-ACB-NW-BUS-1	Not shown	Stranded wire “divot” growth	6
1-ACB-NW-BUS-1	Not shown	Stranded wire Wide pit with upper layer that appears to have growth under it	21.7
1-ACB-NW-BUS-1	Figure 27	Stranded wire Wavy layer with wide pit	8.5
1-GR-NW-1	Figure 18	Outer layer with what appears to be growth underneath	11.4
2T-RS-HW1	Not shown	Blister growth	16.4
2T-RS-HW1	Not shown	Blister growth	25.7
2T-RS-HW1	Not shown		26.2

Elemental maps for the neutral wire are shown in Figure 26 and Figure 27. A continuous sulfide film can be seen, with subsurface attack of the base metal which is typical of copper sulfidation reactions. In the void formed in the base metal, oxidation has occurred, filling the cavity with copper oxide and/or copper sulfate.

Figure 26. EDS map of wire cross section showing oxygen in “pocket. The elemental maps for Cu (red), S (green), and oxygen (blue) are shown.

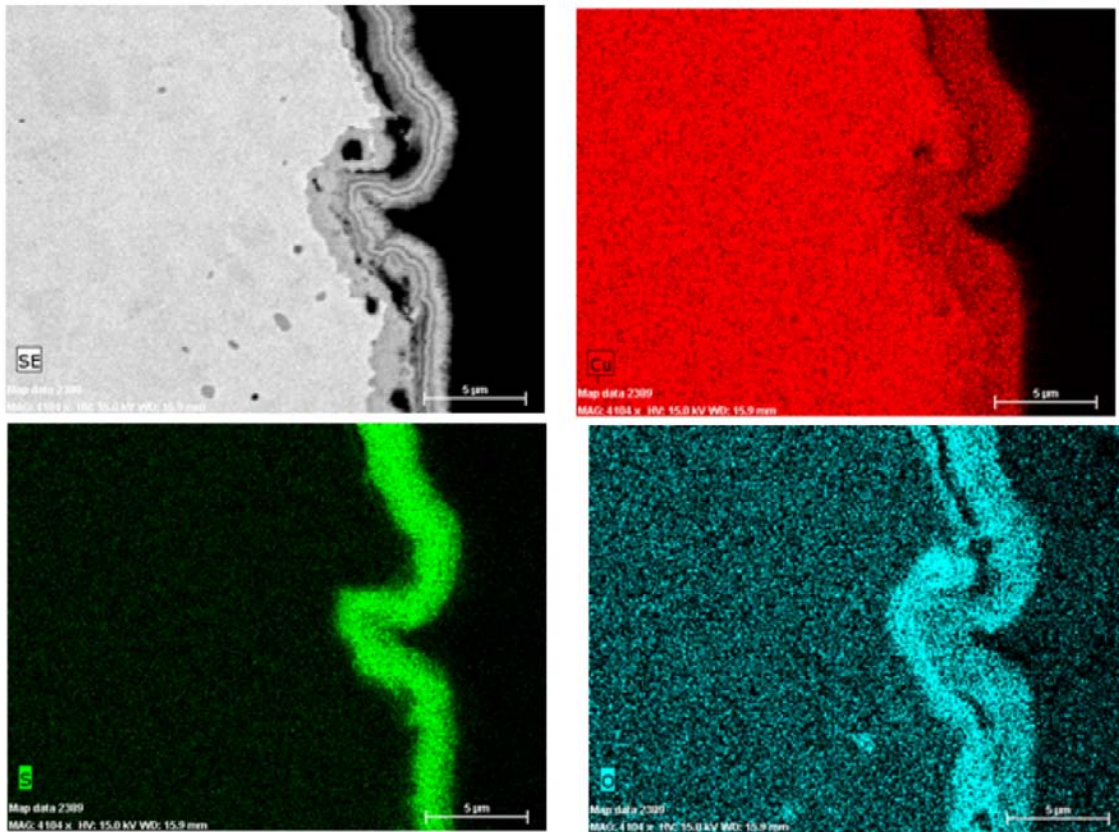
1-ACB-NW-BUS-1\_map2

Figure 27. Elemental maps taken on cross section of the neutral wire from the arc-fault circuit breaker from Circuit 1. The image at the top left is an SEM image of the area being analyzed. The elemental maps for Cu (red), S (green), and oxygen (blue) are shown.

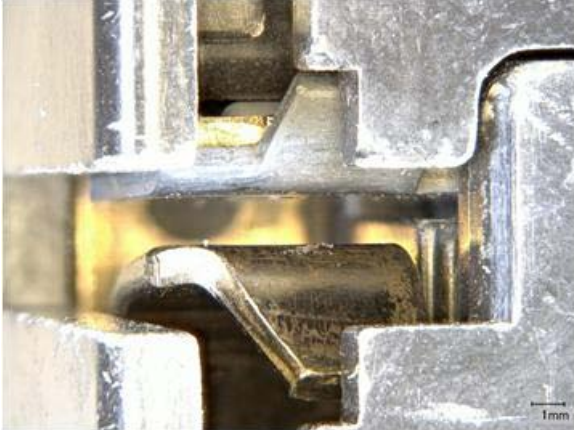
Figure 29 shows optical images of the contact surfaces of the standard circuit breaker from Circuit 1. Corrosion of the upper contact is visible. The lower contact appears to be plated, or constructed of a different material. It did not exhibit extensive corrosion.

Figure 29. Optical images of the contacts in the standard circuit breaker in Circuit 1.

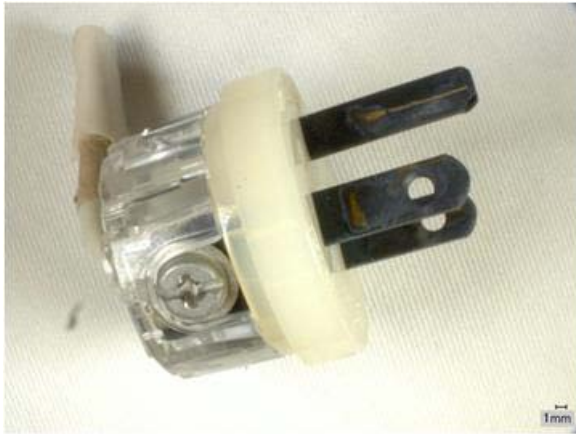
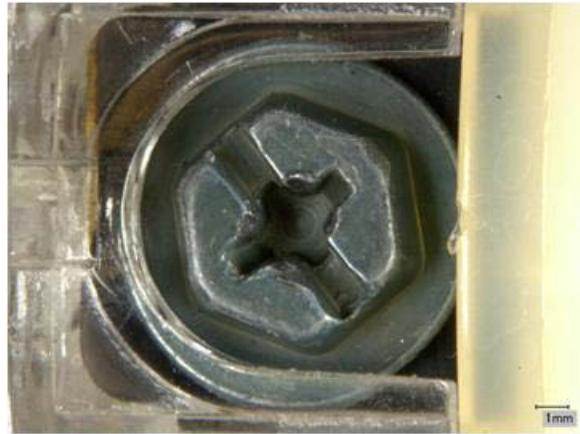
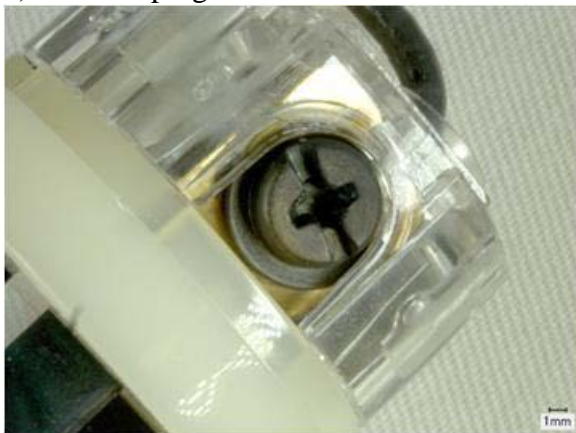
Figure 30 shows images of the plug used to connect the standard receptacle to the GFCI receptacle in Circuit 1. Note that the contact surfaces exhibit corrosion, even when inserted into the socket. Also, note that there are areas of contact that prevented or reduced the attack of the base metal.

Figure 30. Optical images of the plug used to connect the standard receptacle to the GFCI receptacle in Circuit 1. The prongs and screws are blackened relative to those on a new, as-received, unexposed plug.

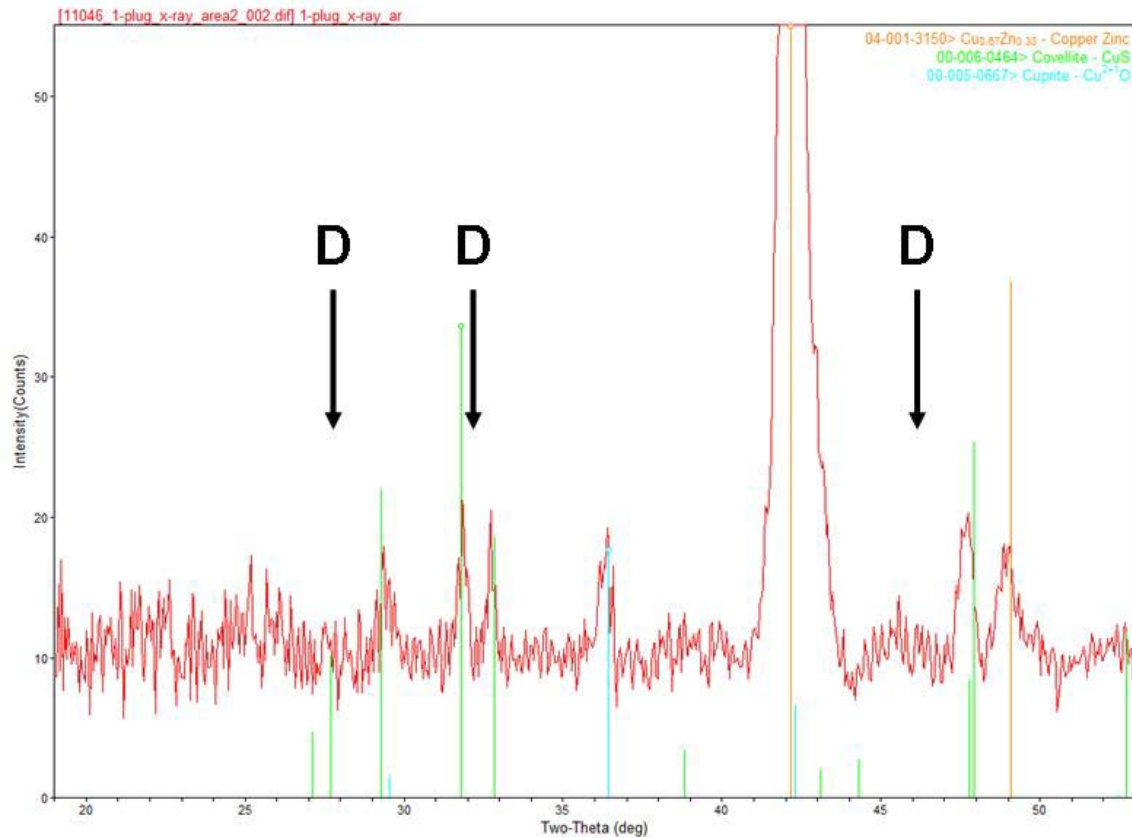
Corrosion product was scraped from the “hot” prong of the plug and analyzed by XRD, and an *in situ* spot was analyzed by  $\mu$ XRD. These tests detected that the base metal is a copper-zinc alloy and revealed the presence of a covellite ( $\text{CuS}$ ) copper sulfide phase. Additional phases detected only by XRD include: copper sulfate hydroxide hydrate and copper zinc sulfate hydroxide hydrate (Ktenasite), whereas, only cuprite  $\text{Cu}_2\text{O}$  was detected by  $\mu$ XRD. Lack of full cross-validation of XRD and  $\mu$ XRD is expected due to the differences in counting statistics and sampling area. The  $\mu$ XRD spectrum is shown in Figure 31 and illustrates the peaks attributable to the covellite, cuprite, and copper-zinc alloy. The figure is also labeled with the approximate locations where a digenite copper sulfide phase would be detected.

Figure 31.  $\mu$ -XRD data for ground prong of plug from Circuit 1, showing cuprite (blue), covellite (green), and copper/zinc (orange) peaks observed and labels where digenite (D) peaks would occur, if present.

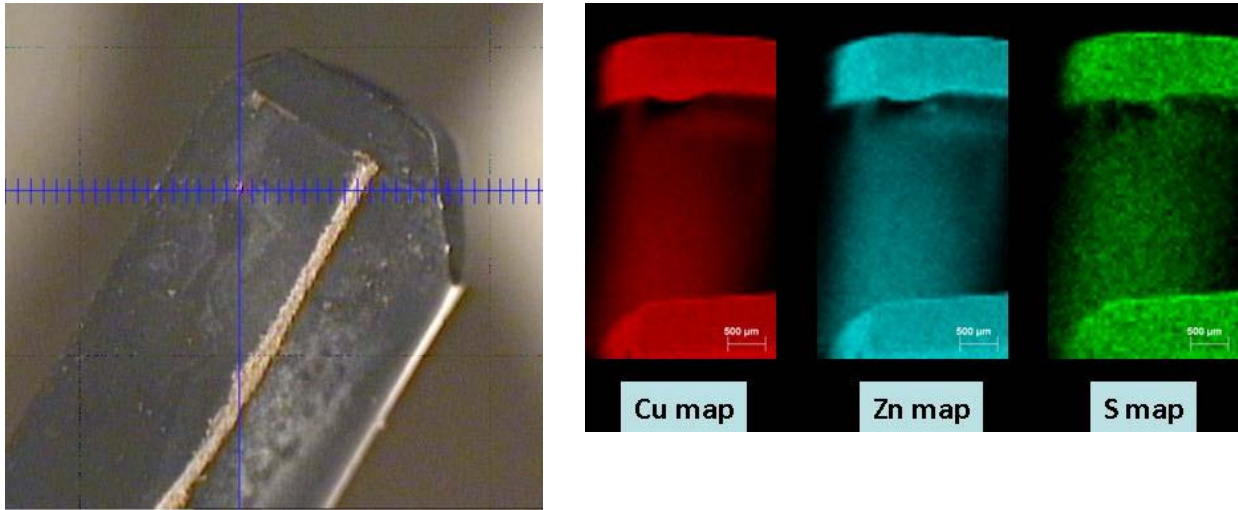
A copper-zinc alloy was detected for the ground prong of the plug by XRF analysis, and the elemental map, Figure 32, shows that the sulfur coverage is uniform within the tested length (approximately 2.5 mm) near the prong end.

Figure 32. Photo of one side of ground prong and XRF element maps of ground prong of grounded plug. XRF images taken “end-on” of full prong.

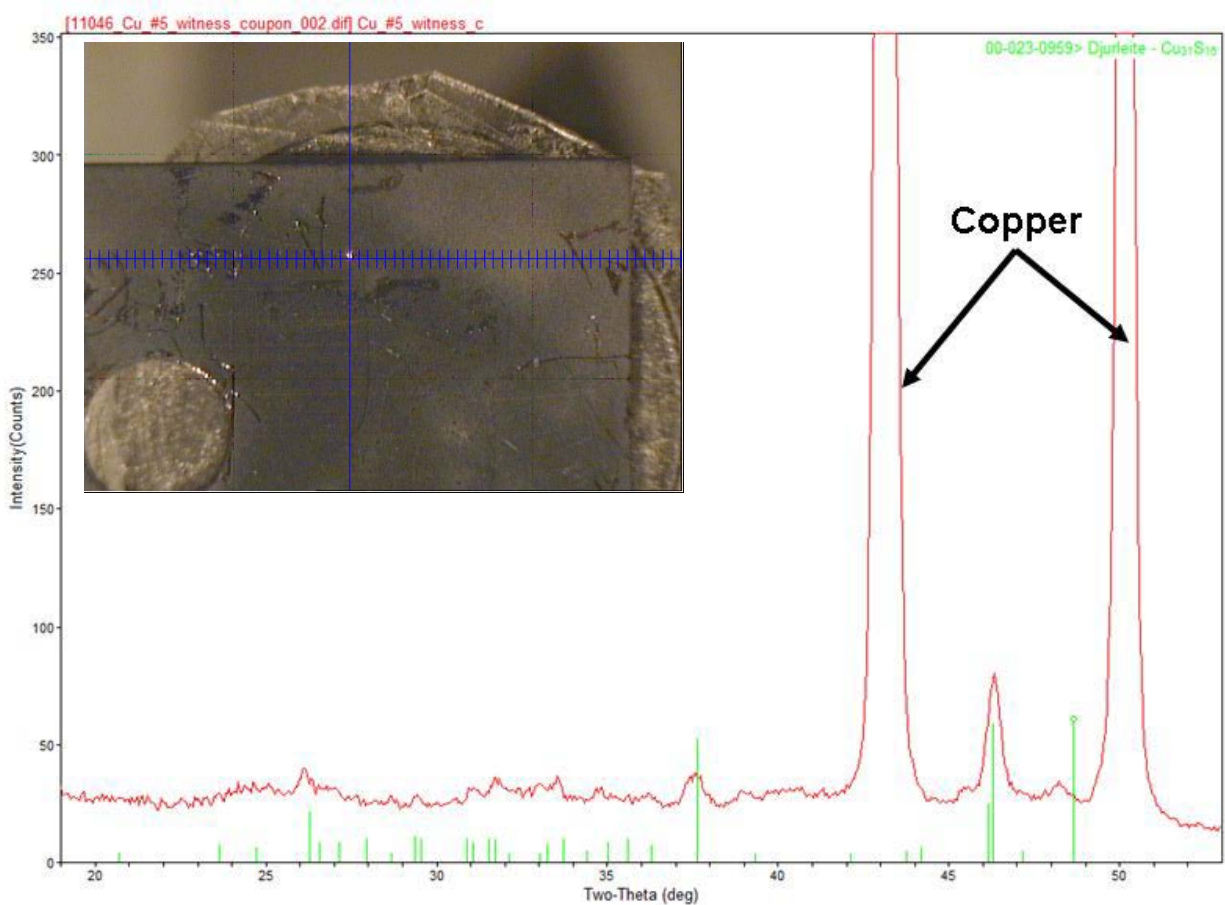
XRD of scraped powder and *in situ*  $\mu$ XRD both detected the copper sulfide phase known as “djurleite” ( $\text{Cu}_{31}\text{S}_{16}$ ) as the predominant corrosion product observed on copper witness coupon No. 5. Data for the  $\mu$ XRD, along with the image indicating the location of the analysis, are shown in Figure 33. The image shows the copper witness coupon (which has a small hole for mounting, which was not used in these tests) on top of the metal instrument sample holder. The grey to bluish-black appearance of the sample is consistent with the appearance of djurleite. Both XRD and  $\mu$ XRD techniques verify also that the witness coupon is pure copper.

Figure 33. Video image (inset) showing location of  $\mu$ XRD analysis and  $\mu$ XRD data for witness coupon No. 5, showing labeled copper and djurleite peaks (green).

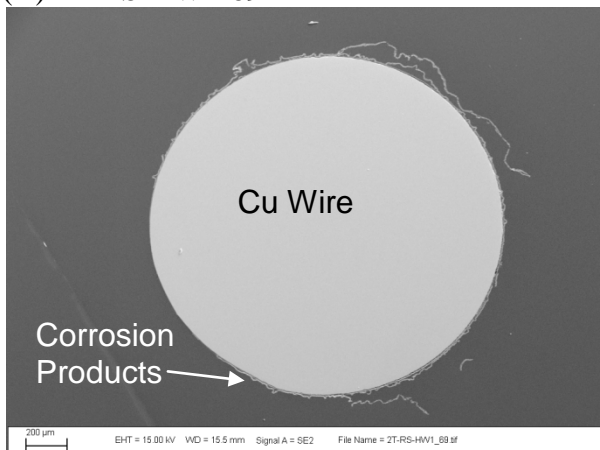
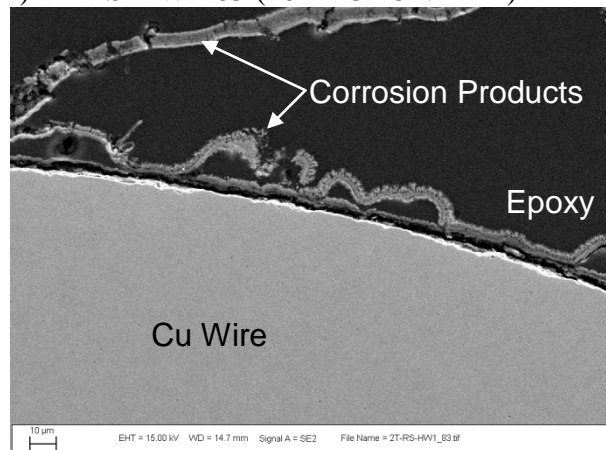
Figure 36 shows SEM images of the hot wire (screw connected) from the rocker switch. As with other components, there is evidence of film growth and rupture. It is important to note that the thickness of the corrosion product film is very small relative to the diameter of the wire. In other words, copper sulfidation under these conditions is a surface phenomenon and does not result in significant reduction in the cross sectional area of the conductor. As such, the corrosion process will have no effect on the current carrying capabilities of the wire.

Figure 36. SEM images of the cross section of the rocker switch hot wire from Circuit 2. The image on the left shows a low magnification image of the wire, with a high magnification image showing details of the corrosion product layer presented in the figure on the right.

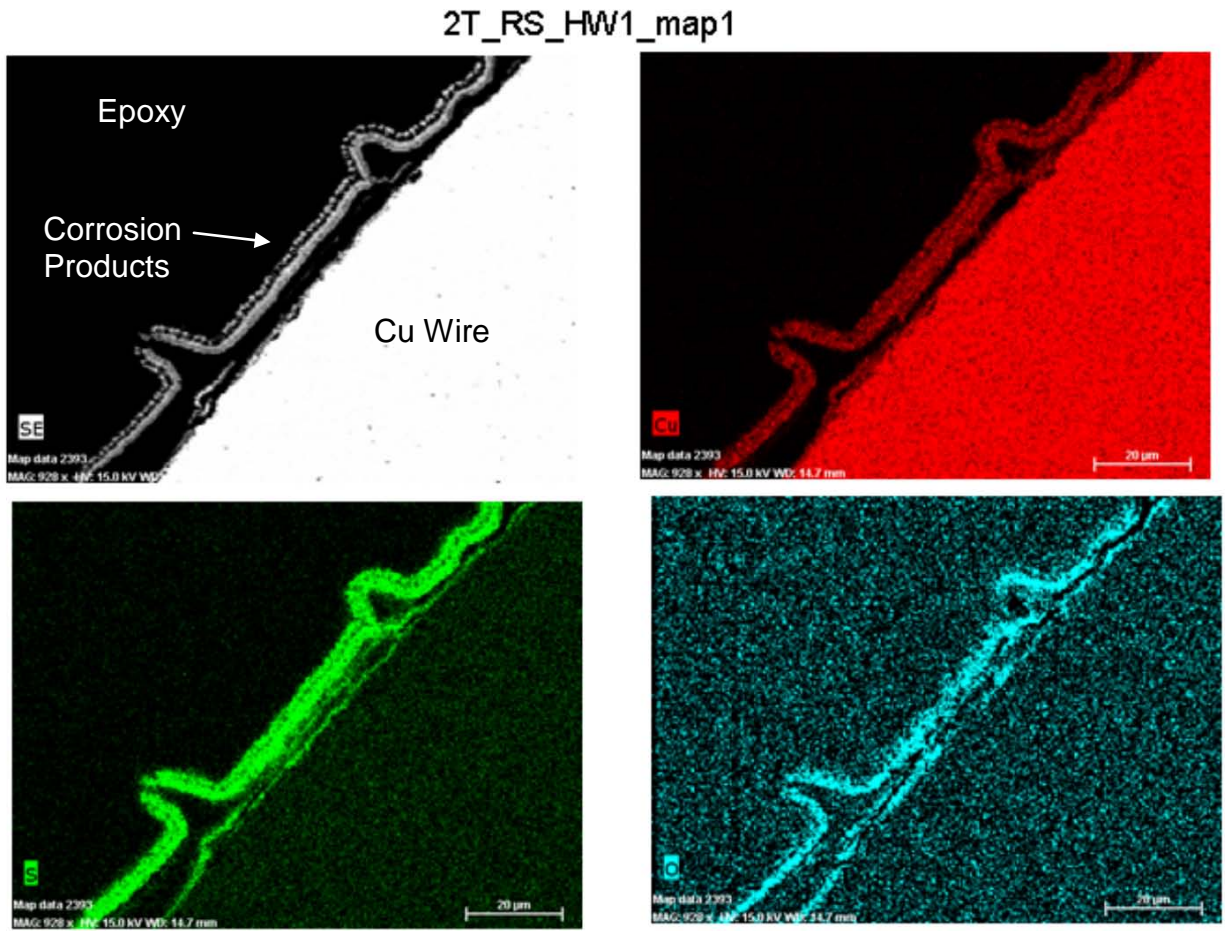
Figure 37 shows the elemental maps of the wire shown in Figure 36. The corrosion product consists of a layer of copper sulfide, with a thinner layer of either copper oxide or possibly copper sulfate.

Figure 37. Elemental maps from the rocker switch hot wire (cross sections) in Circuit 2. The upper left image is an SEM image identifying the area being analyzed. Three maps are shown for Cu (red), S (green), and oxygen (blue).

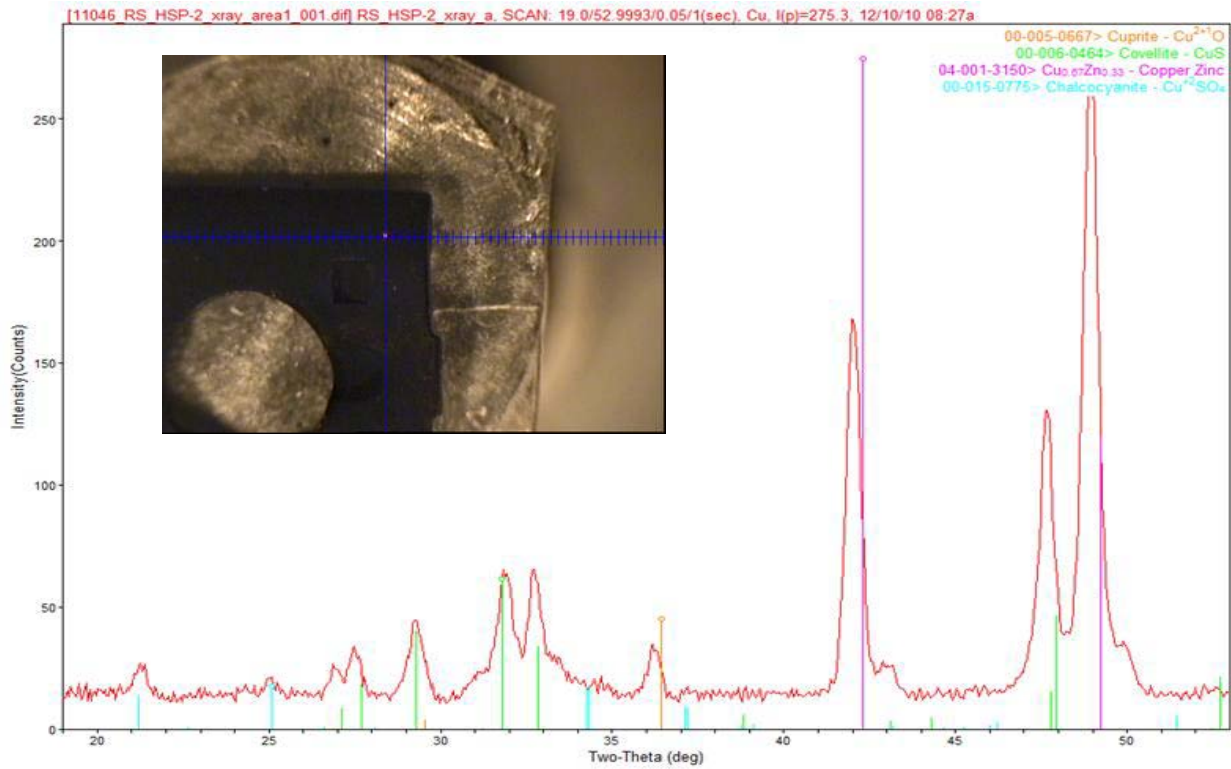
XRD analysis of scraped powder from this contact plate detected the same phases that were detected in the powder scraped from the Circuit 1 plug: covellite, copper sulfate hydroxide hydrate, Cu-Zn sulfate hydroxide hydrate (Ktenasite), and a copper-zinc alloy (as the  $\text{Cu}_{0.67}\text{Zn}_{0.33}$ ).  $\mu\text{XRD}$  analysis was also consistent with that of the Circuit 1 plug, detecting cuprite, covellite, and copper-zinc alloy. Additionally a chalcocyanite phase ( $\text{CuSO}_4$ ) was detected *in situ* on this part. The location of sampling and  $\mu\text{XRD}$  data are shown in Figure 38. The large metal piece behind the sulfidated (black) part is the instrument sample holder.

Figure 38. Video image (inset) and  $\mu\text{XRD}$  data for 2-RS-HSP-2 (contact plate), showing cuprite (orange), covellite (green), and copper/zinc (purple), and chalcocyanite ( $\text{Cu}^{2+}\text{SO}_4$ -light blue) peaks observed.

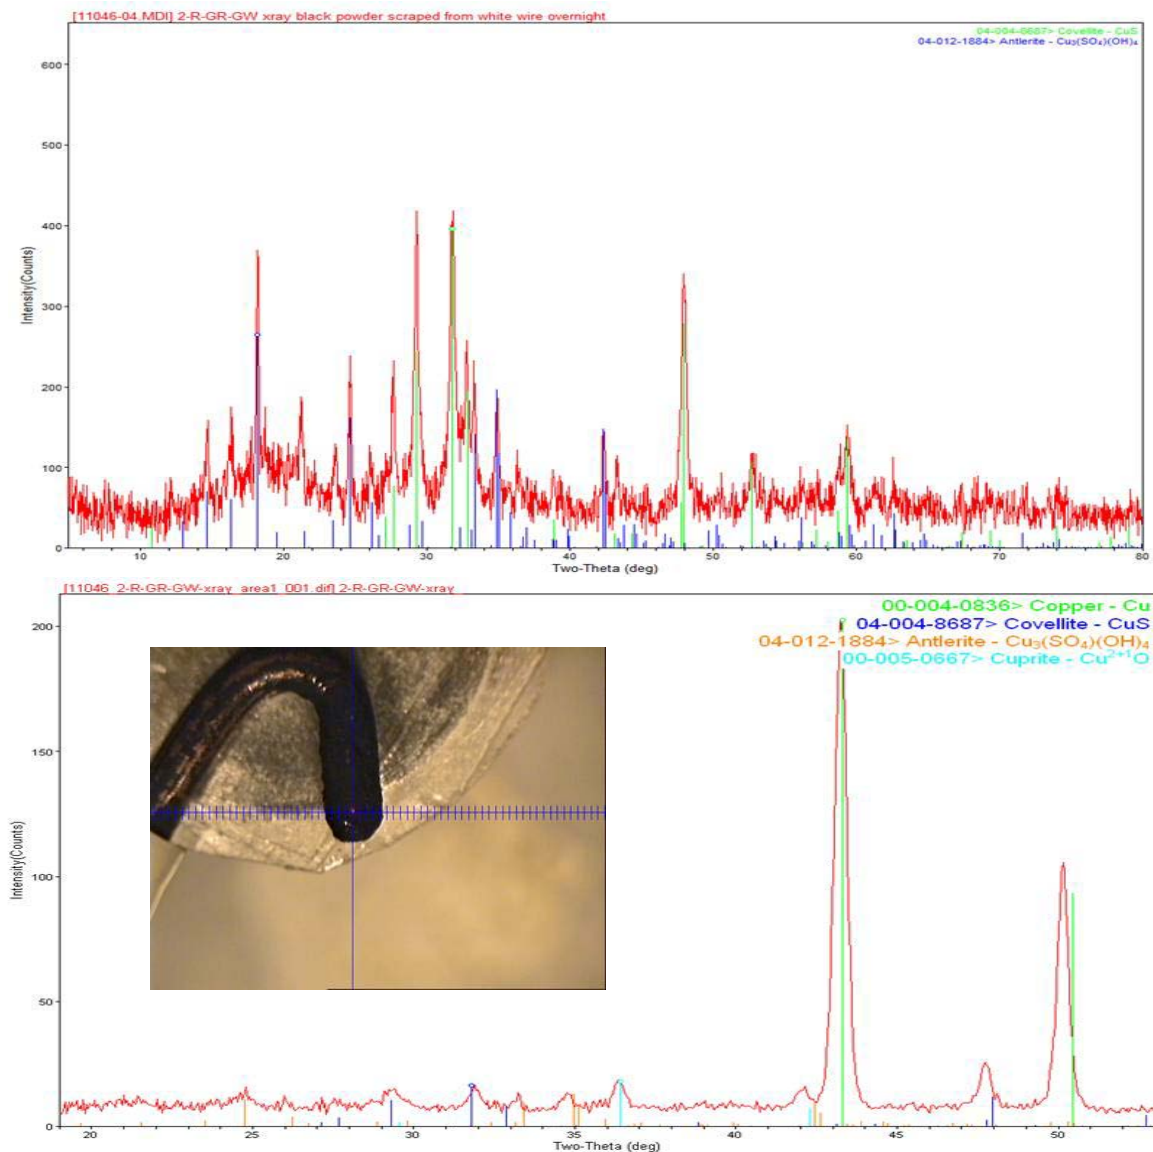
XRD analysis of black powder scraped from the wire surface (top, Figure 39) and  $\mu$ XRD *in situ* of the ground wire (bottom, Figure 39) of the GFCI component of Circuit 2 detected covellite ( $\text{CuS}$ ) and the antlerite copper sulfate hydroxide phase ( $\text{Cu}_3(\text{SO}_4)(\text{OH})_4$ ). In addition, the  $\mu$ XRD data shows copper oxide (cuprite) and copper metal.

Figure 39. XRD data (top) for powder scraped from wire 2-R-GR-GW showing covellite (green) and antlerite (blue), and  $\mu$ -XRD data (bottom) showing antlerite (orange), cuprite (light blue), covellite (dark blue), and copper (green) peaks.

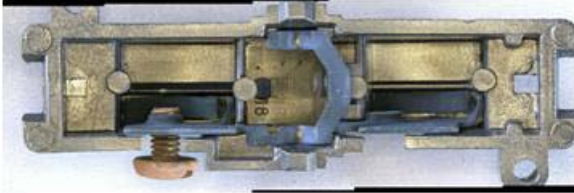
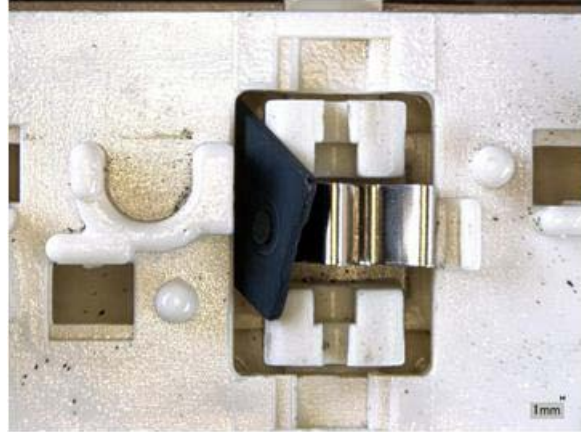
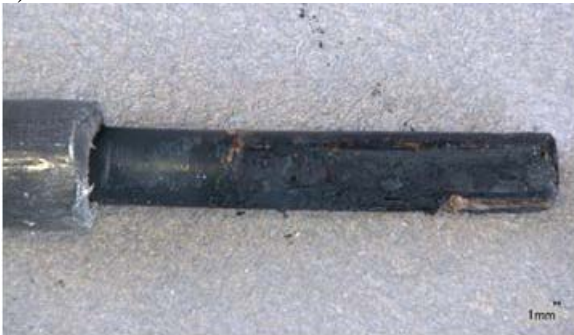
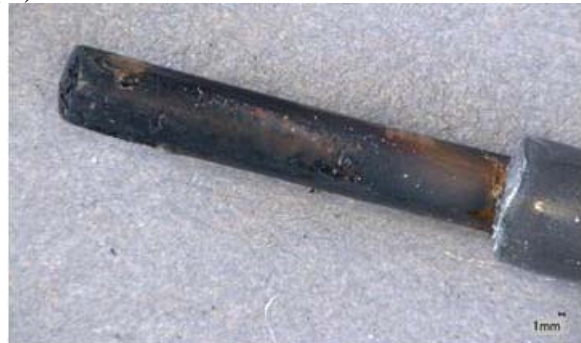
Figure 40 shows optical images for the rocker switch from Circuit 3. The case was removed to reveal the interior components. As with other components, it appears that the case provides little or no protection against the corrosive gasses. Both interior and exterior components exhibit corrosion. The bottom two images show both sides of the hot wire. In this case, the wire was connected to the push-in contact. Corrosion of the wire surface was less nonuniform, but it essentially covered the entire surface other than the contact point.

Figure 40. Optical images of the rocker switch and hot wires from Circuit 3.
