# **Report on Study of Electrical Component Corrosion Related to Problem Drywall**

U.S. Consumer Product Safety Commission

March 2011

## **Report on Accelerated Corrosion Studies of Electrical Components**

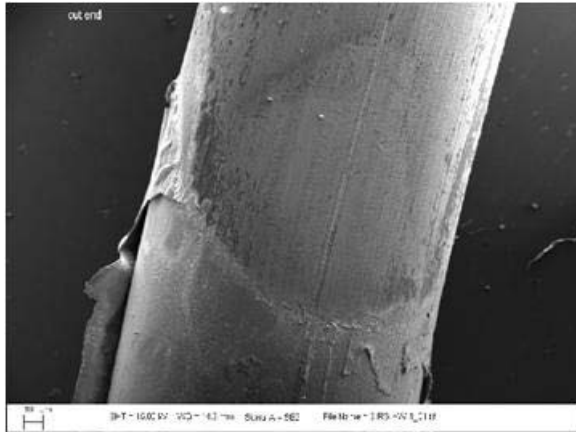
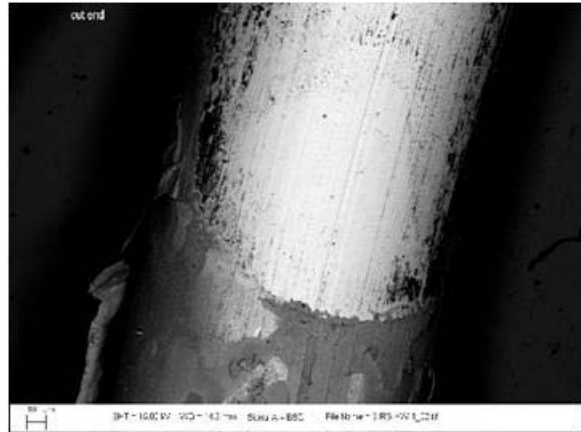
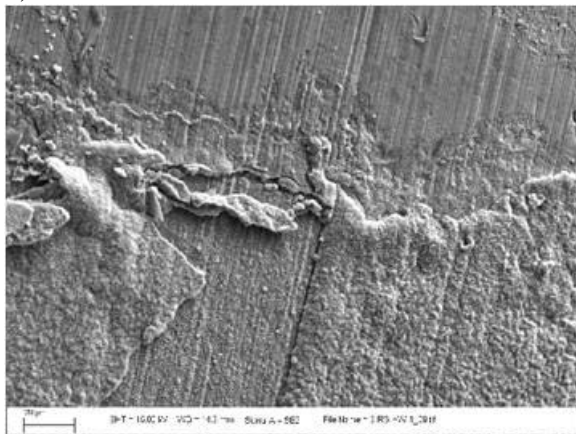
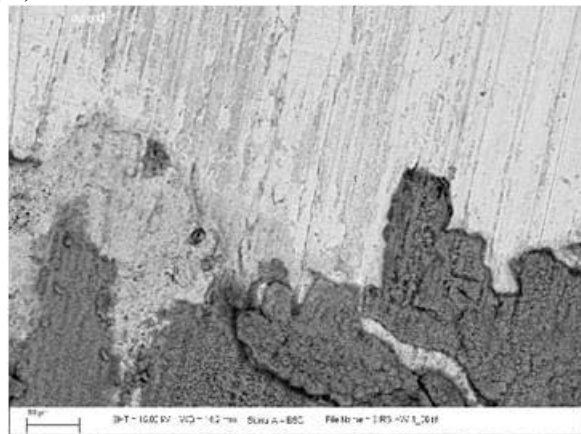
Figure 41 shows SEM images of the hot wire from the rocker switch. The figures on the left are secondary electron images that show topography. In this case, the insulation was removed next to the corroded area. The images on the right are back-scattered electron images. In these images, brightness is a function of the atomic number of the element on the surface. The bright area in the top of the image represents bare copper exposed by the removal of the insulation; the lower portion of the picture is darker and represents the sulfide layer (*i.e.*, copper has a higher/larger atomic number than sulfur). These images show that sulfidation of the copper stops where the insulation protects the underlying copper. Figure 42 shows the elemental maps associated with this location. Clearly, the insulation protected the underlying copper from sulfidation because the top of the elemental maps showing the region of the wire that was covered with insulation shows no sulfur.

Figure 41. SEM images of the hot wire from the rocker switch in Circuit 3. The figures on the left are secondary electron images, which show topography. The images on the right are back-scatter images. In these images, brightness is a function of the atomic number, with higher brightness indicating elements of higher atomic number.

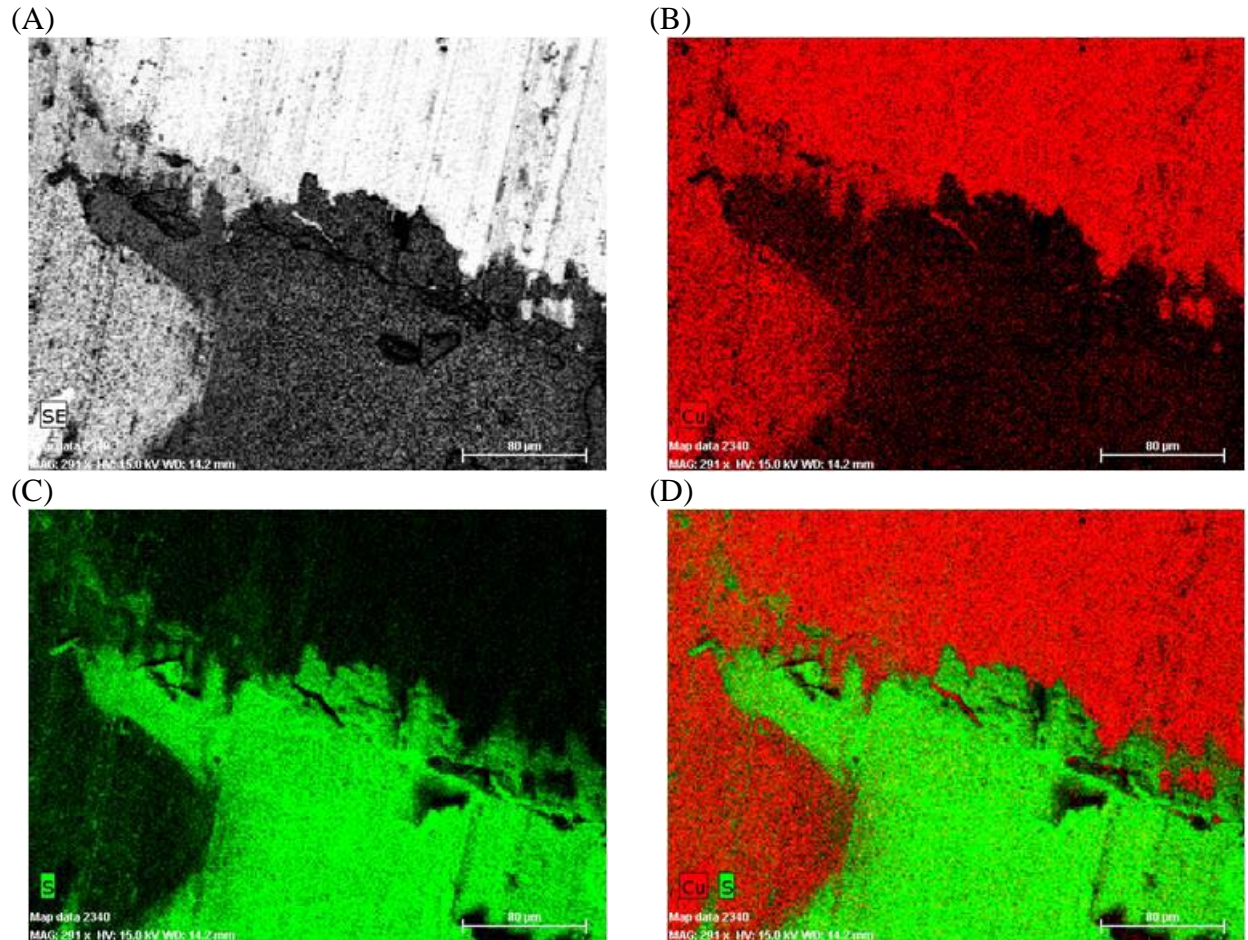
Figure 42. EDS elemental maps of the hot wire from the rocker switch in Circuit 3. Images include A the SEM image, (B) a copper map (red), (C) a sulfur map (green), and (D) a combined copper/sulfur map (red and green).

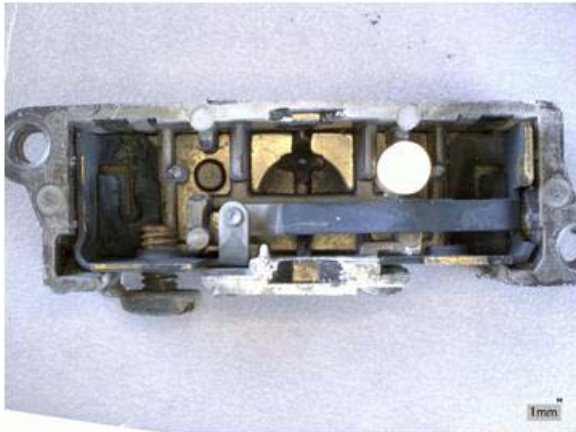
Optical images of the toggle switch from Circuit 3 are shown in Figure 43. As with previous components, sulfidation was universal, except where the surface was shielded (contact points).

Figure 43. Optical images of the toggle switch in Circuit 3. The figure on the left shows the inside of the switch. Note the extensive corrosion product on some of the components. The image on the right is of the hot wire connected to the toggle switch (screw side).

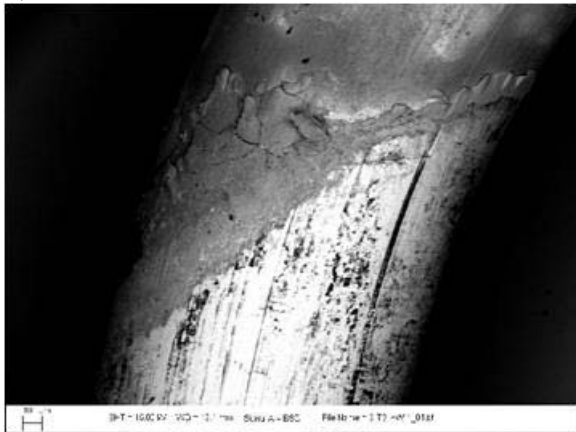
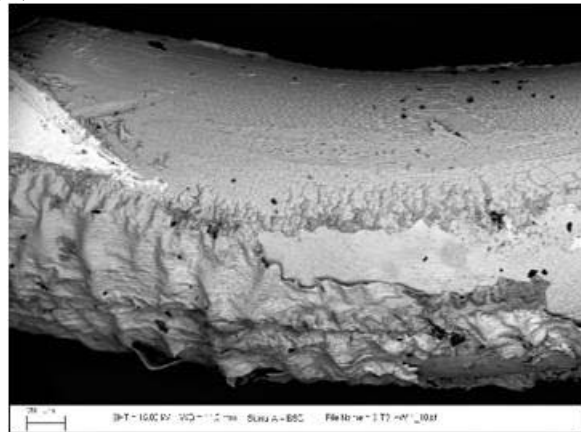
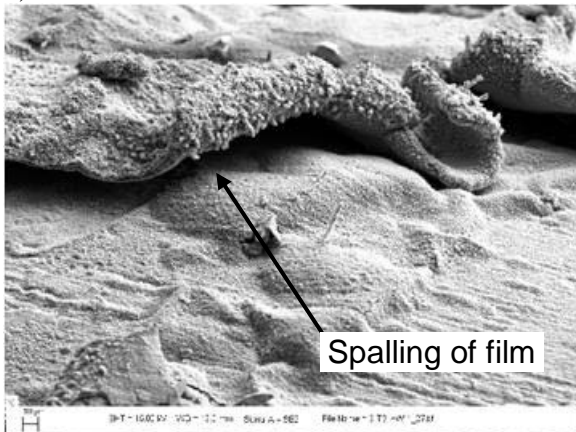
Figure 44 shows SEM images of the hot wire from this component. The top two images are back-scattered electron images and show the presence of bare Cu at a contact point (light region). The corrosion product film structure/morphology is similar to that found on other components, exhibiting layering, buckling, and spalling.

Figure 44. SEM images of the hot wire from the toggle switch in Circuit 3. Note the spalling of the corrosion product film. The contact areas can be seen in the upper two images (bright areas) where the contact shielded the surface from the corrosive gasses.

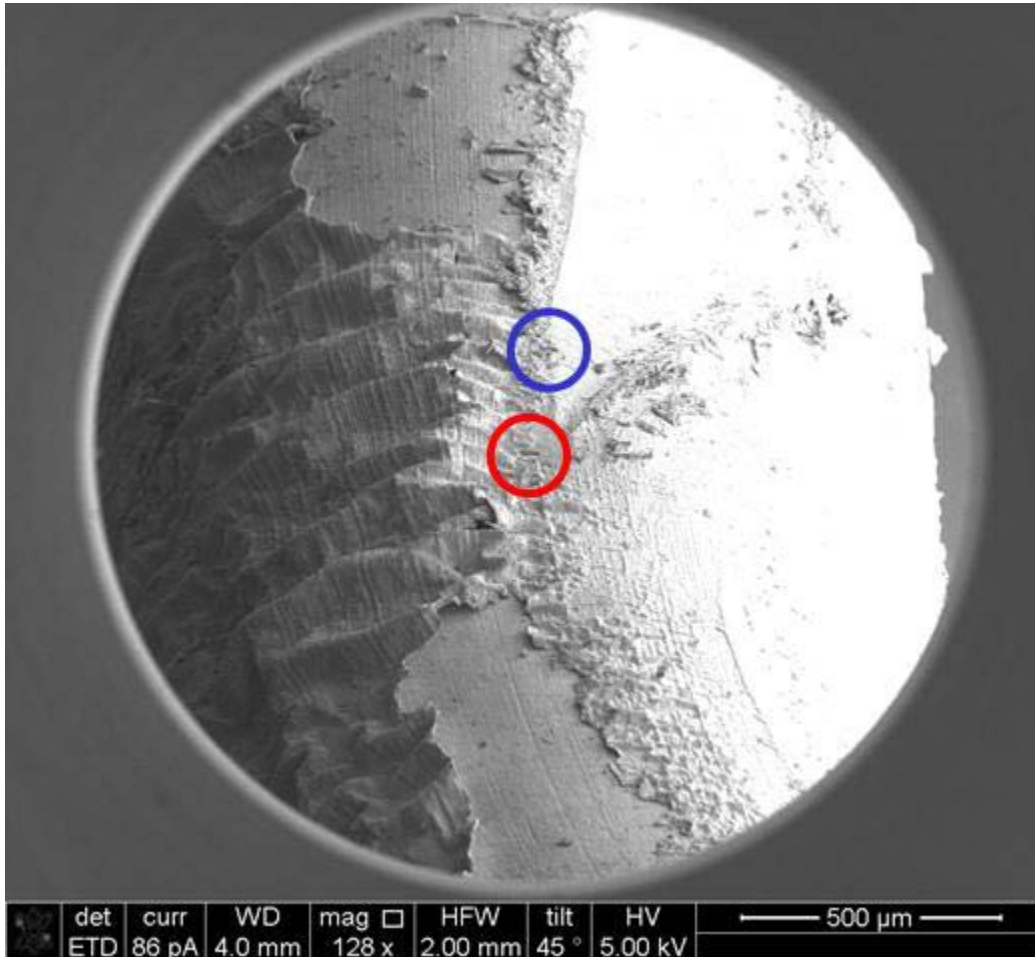
potentially less damaging to the surface layers; however, it is time consuming; therefore, only limited FIB analyses were performed. Figure 46 shows a low magnification view with circles indicating locations of two FIB cuts. Since this is a very low magnification, the instrument aperture is observed as the wider circle. The bright area in the upper right, is the area where the screw made contact with the wire and appears to be free of corrosion product.

Figure 46. Low magnification FIB image of hot wire from toggle switch (3TS-HW-1), showing location of FIB cuts (red designated as “Section 1” and blue designated as “Section 2”) into corrosion product film.

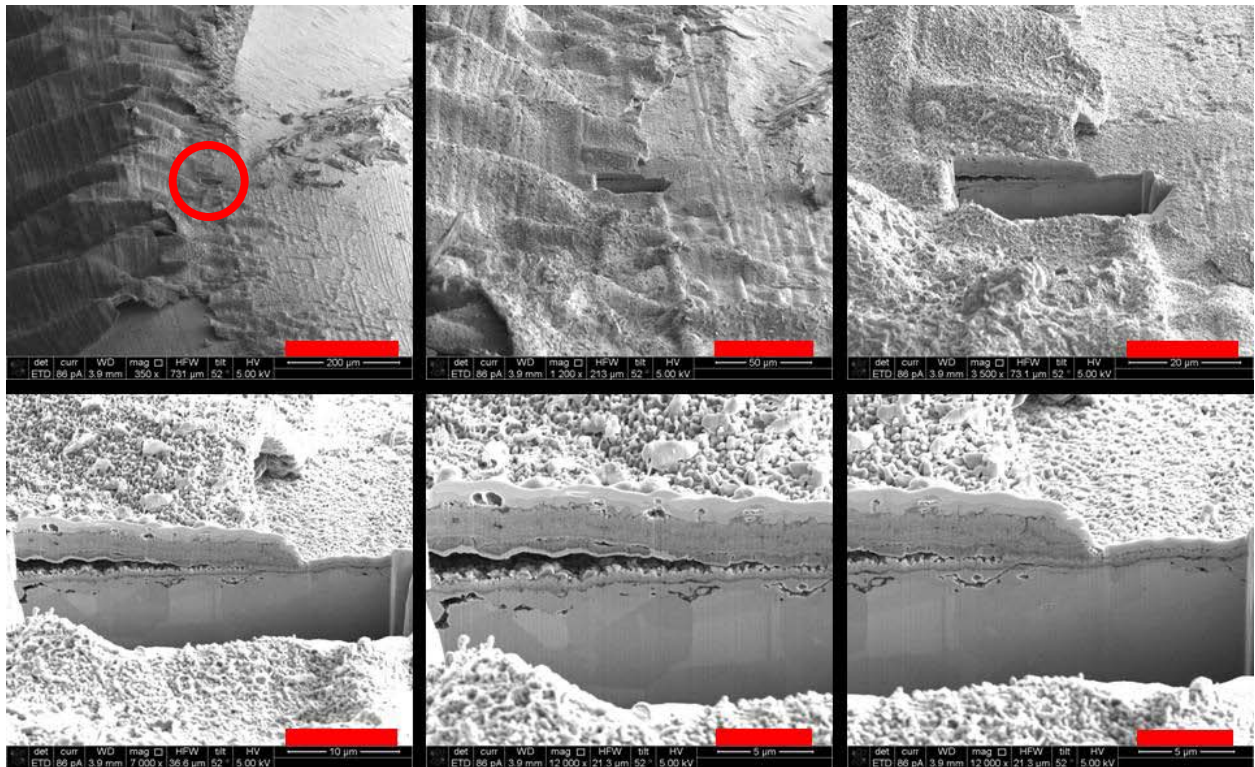
Figure 47 shows SEM images of the FIB cut designated as “Section 1,” indicated by the red circle in the previous figure, at increasing magnifications (350 to 12,000X magnification). This FIB cut is approximately 50 microns from the nearest portion of the wire contacted by the screw. The middle top image illustrates wavy features of the corrosion product observed in SEM cross sections of other samples. The right top and lower left images illustrate an abrupt edge of the wavy growth that appears to have smaller features, suggesting flaking and regrowth of the corrosion product. The middle lower and right lower images show closer views of the corrosion layer and the varying gap between the wire and corrosion product. This is consistent with crosssection observations of other wires.

Figure 47. FIB cuts into 3-TS-HW-1 “Section 1” (see Figure 46) with scale bars at 200 (350X), 50, 20, 5, and 5 (12,000X) microns, respectively.

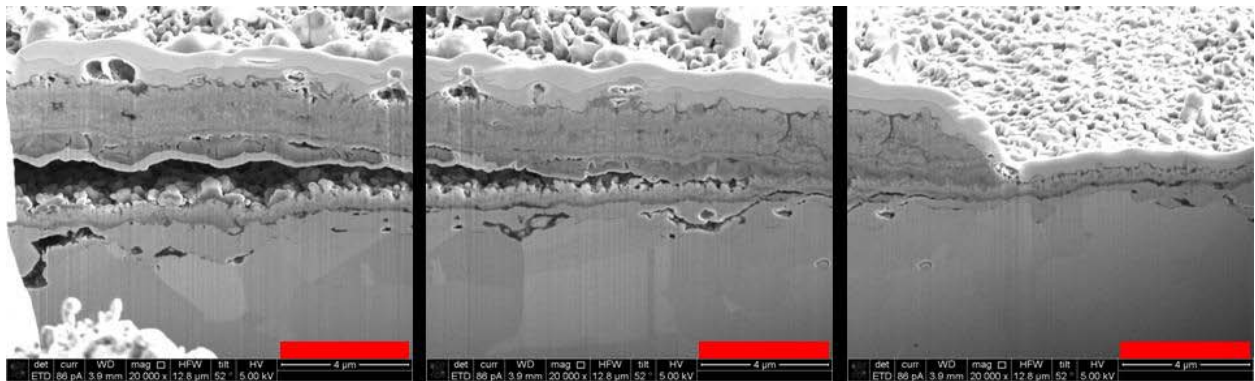
Figure 48 shows three images at the same magnification (20,000X) of the edge of the FIB cut. The copper wire is at the bottom, the varying contrast areas are consistent with solid copper. Some pitted areas are observed along with roughened product growth underneath the upper layer of corrosion. The bright white top layer is the platinum layer deposited on the sample to preserve features.

Figure 48. FIB cuts into 3-TS-HW-1 “Section 1” (see Figure 46) with scale bars at 4 microns each.

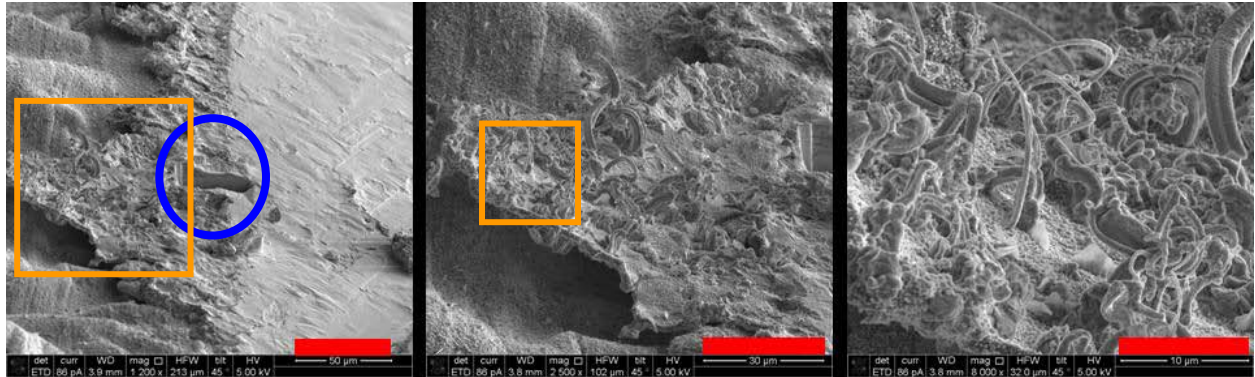
Interesting growth morphologies were seen in all samples, which included needles and other features. One example, with needle and spiral-like growths, observed near the FIB cut is shown

Figure 49. FIB cuts into 3-TS-HW-1 “Section 2” (see Figure 46) with scale bars at 50, 30, and 10 microns, respectively.

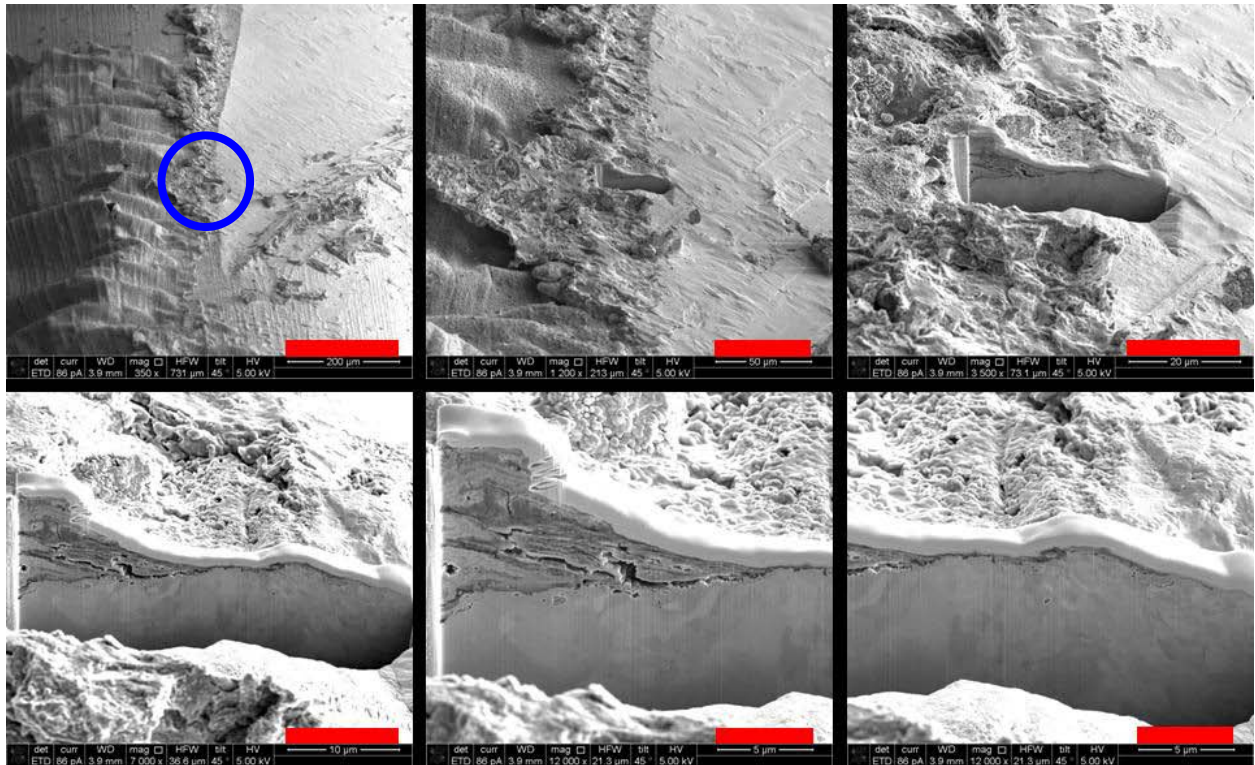
A closer look at the cross section of corrosion growth revealed by the FIB cut designated as “Section 2” is shown in Figure 50. In the top row, a bare copper area is observed to the upper right of the images, the area underneath the screw. The lower row shows higher magnification views of the change in the corrosion growth thickness from left to right.

Figure 50. FIB cuts into hot wire from Circuit 3 toggle switch (3-TS-HW-1) “Section 2” (see Figure 46) with scale bars at 200, 50, 20, 10, 5, and 5 microns, respectively.

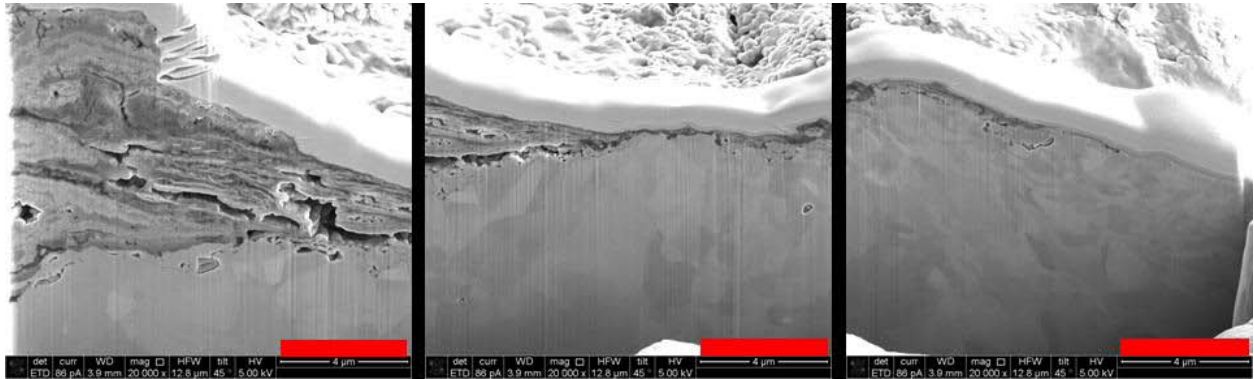
Figure 51 contains a series of SEM images across the FIB cut at 20,000X magnification. Layering and pitting is observed; moving from left to right and closer to the contact point of the screw, the overall corrosion thickness transitions from approximately nine microns to significantly less than one.

Figure 51. FIB cuts into 3-TS-HW-1 “Section 2” (see Figure 46) with scale bars at 4 microns each (20,000X).

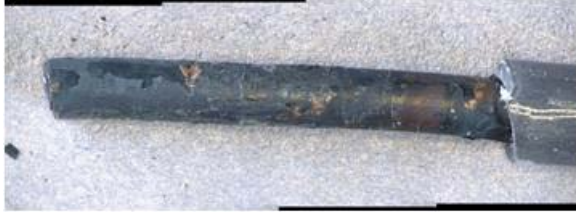
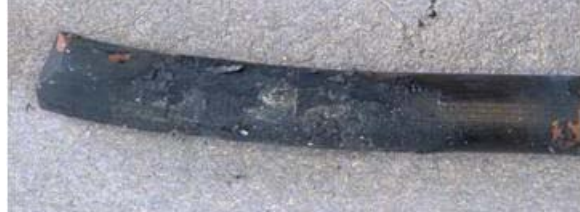
Figure 53 shows optical images of the hot wires (push-in contacts) from the standard receptacle from Circuit 3. These results are consistent with previous samples, showing corrosion product across the surface except where the contact was made.

Figure 53. Optical images of wires from the standard receptacle from Circuit 3. Both the (A) hot and (B) neutral wire are shown. Both are “push-in” type contacts.

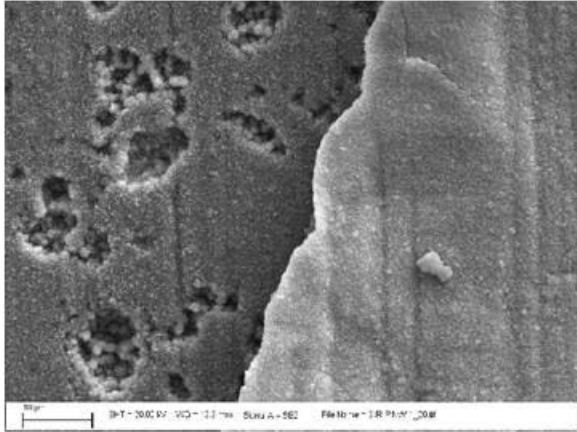
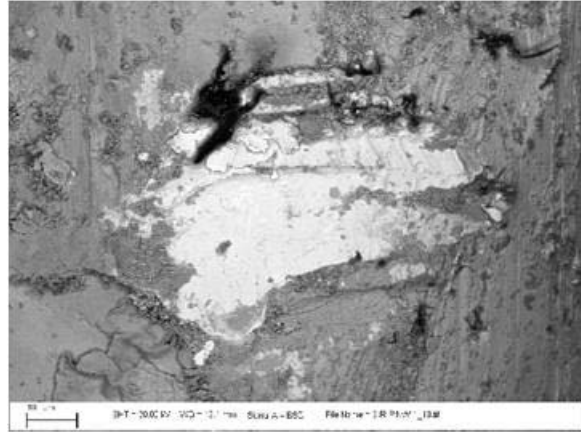
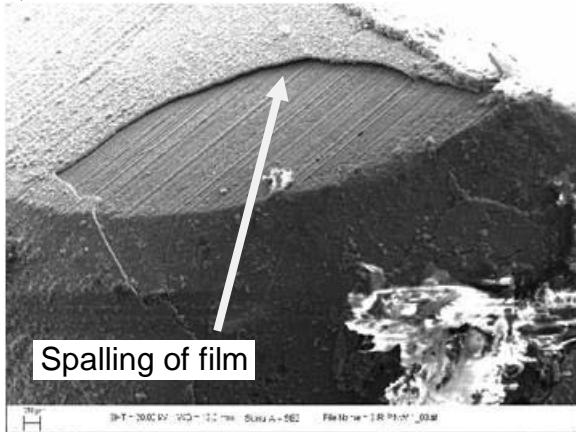
The SEM images shown in Figure 54 show similar features to other samples: multiple layers of the film, spalling, voiding of the metal, and bare metal at the contact point.

Figure 54. SEM images of the surface of the neutral wire from the receptacle in Circuit 3. The connection was a push-in connection. (B) shows the contact point, which is brighter due to the presence of Cu without S. The end of the wire is shown in the lower images at two magnifications. Note the spalling of the corrosion product film. It is believed that the spalling occurred during the test, but is it possible that it occurred after exposure and prior to analysis.

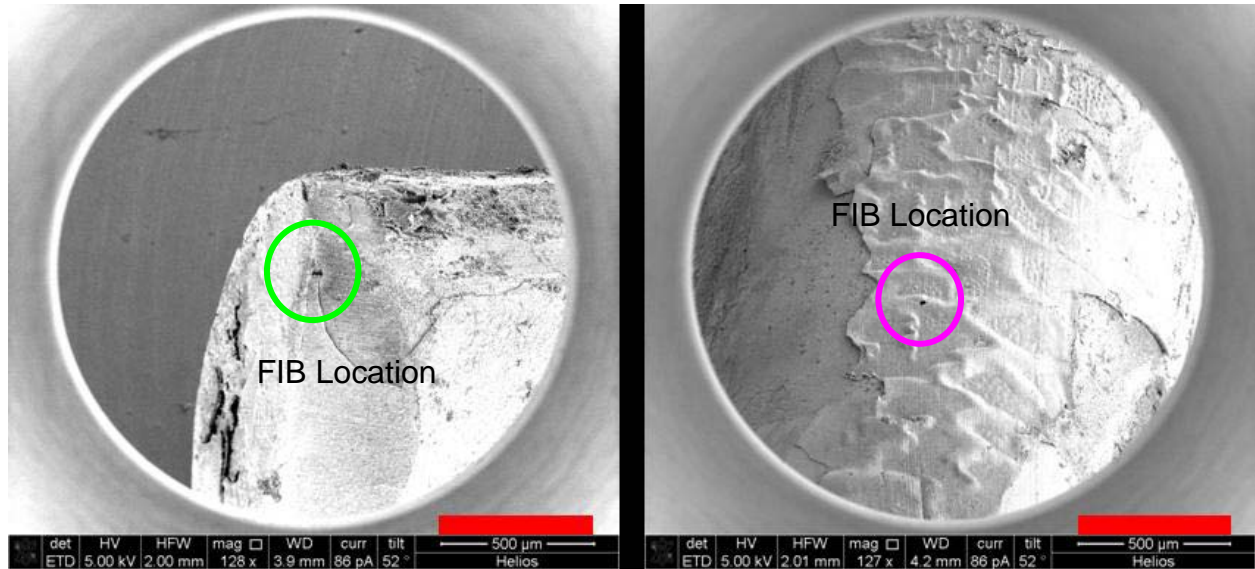
SEM images of two FIB cuts (designated as “Section 3” and “Section 4”) on the neutral wire from the push-in connector of the receptacle are shown below at magnifications of 128x and 127x. The aperture of the instrument is observed as the outer view circle due to wide view and low magnification. “Section 3” (left) was cut at the edge of the corrosion product film. Section 4 (right) was cut into an area surrounded by “wavy” corrosion growth.

Figure 55. FIB cuts into corrosion product on surface of neutral wire 3-R-PINW-1 with “Section 3” (left) and “Section 4” (right) with scale bar of 500 micron.

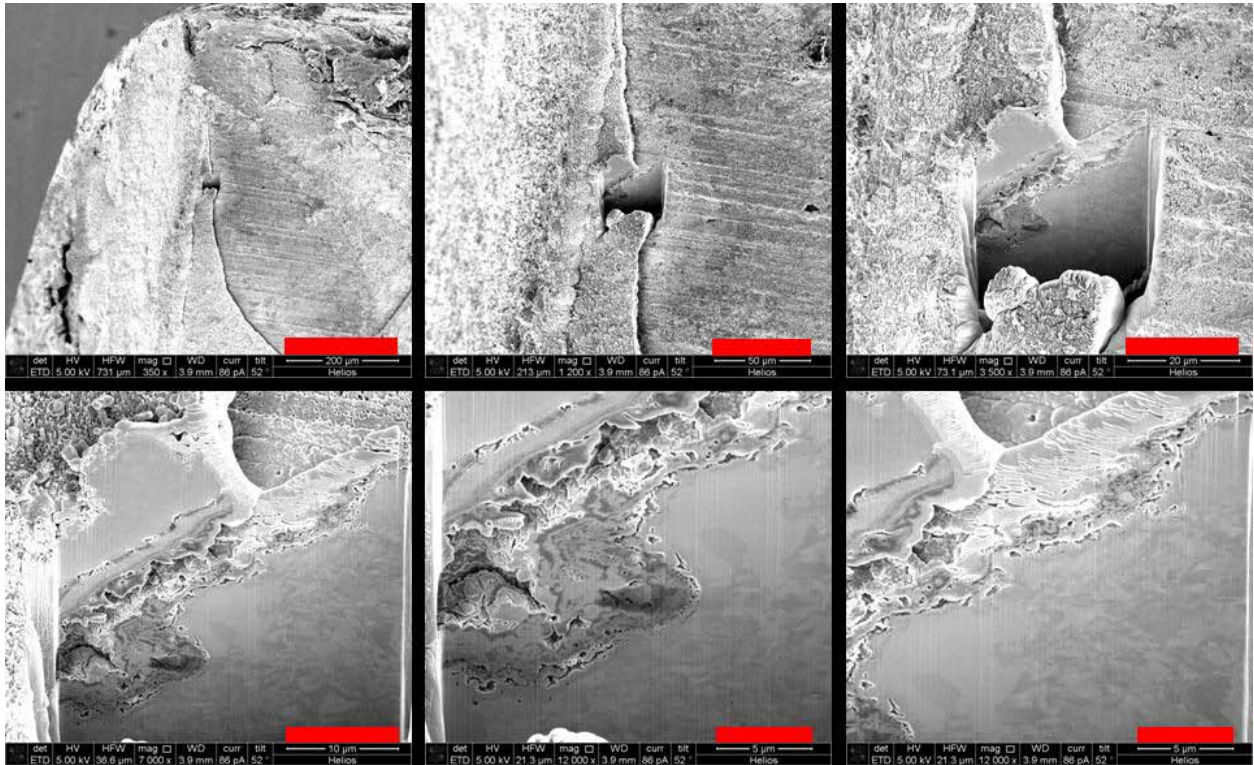
Higher magnification images of “Section 3”, ranging from 350X to 12,000X are presented next (Figure 56) and display varying thickness as well as voiding of the copper below the corrosion product film. The fracture line down the center of the images in the top row shows an area of corrosion product that flaked off.

Figure 56. FIB cuts into neutral wire 3-R-PINW-1 “Section 3” (see Figure 55) with scale bars of 200, 50, 20, 10, 5, and 5 microns.

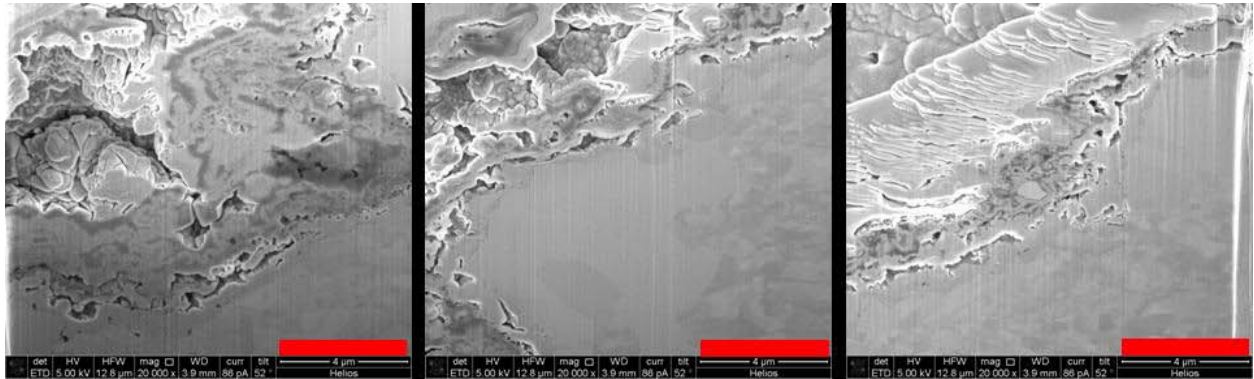
Higher magnification images of the pitting observed in “Section 3” are below (Figure 57); with the thinnest corrosion growth, the platinum FIB coating, and pure copper grains prevalent in the image on the right.

Figure 57. FIB cuts into neutral wire 3-R-PINW-1 “Section 3” (see Figure 55) with scale bars of 4 micron each.

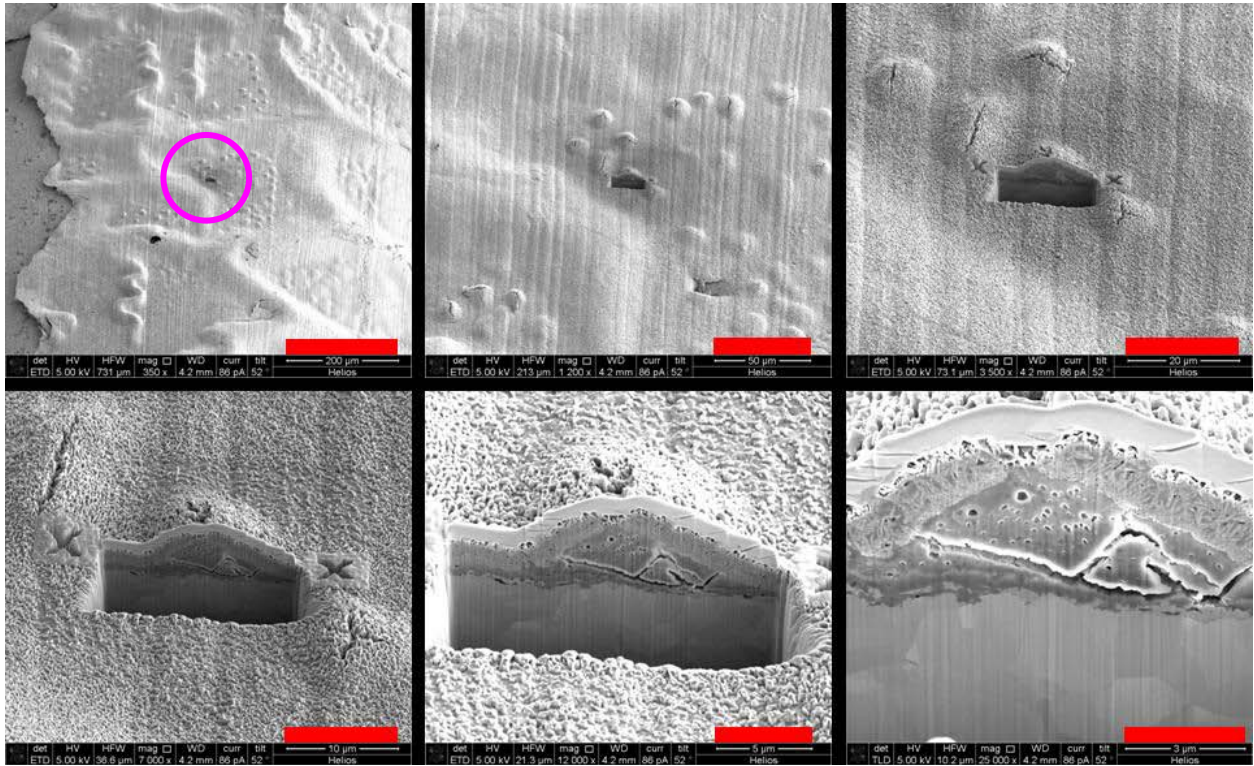
Higher magnification views of “Section 4” are shown in Figure 58 and illustrate an additional morphology seen in some samples—that of a “ bubbling” or blistering of the corrosion product layer. The magnification ranges from 350X to 25,000X. In the lower right image, three different kinds of growth layer are observed—a layer with few voids, a middle layer with multiple voids,

and a third solid layer with what appears to be striated growth. The top-most white layer in the image is the platinum FIB overcoat.

Figure 58. FIB cuts into neutral wire 3-R-PINW-1 “Section 4” (see Figure 55) with scale bars of 200, 50, 20, 10, 5, and 3 microns, respectively.

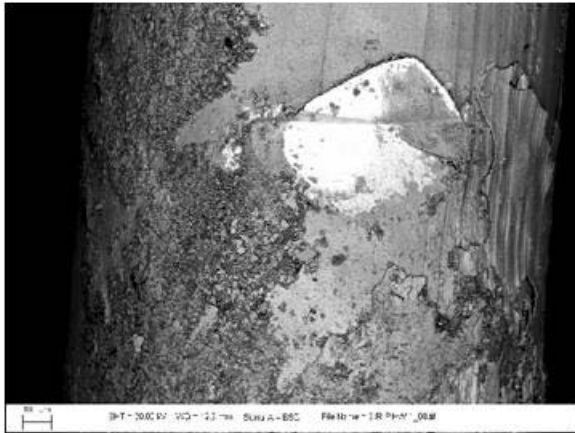
(A) 3-R-PIHW-1\_08

Figure 59 shows SEM images of the push-in hot wire from the receptacle in Circuit 3. The image on the left shows the contact point. It is clear that the intimate contact between the wire and the receptacle contact prevented sulfidation from occurring in the contact area. The image on the right shows the wire at the interface with the insulation. In this case, the insulation was removed to reveal the wire surface directly beneath the insulation. The fact that bare copper is visible in the region shielded by the insulation suggests that the insulation prevents the pollutant gas from contacting the copper wire.

Figure 59. SEM images of the hot wire from the receptacle in Circuit 3. The connection was a push-in connection. The contact point is shown in the image on the left. The image on the right shows a region of a hot wire that was covered by insulation on the bottom.

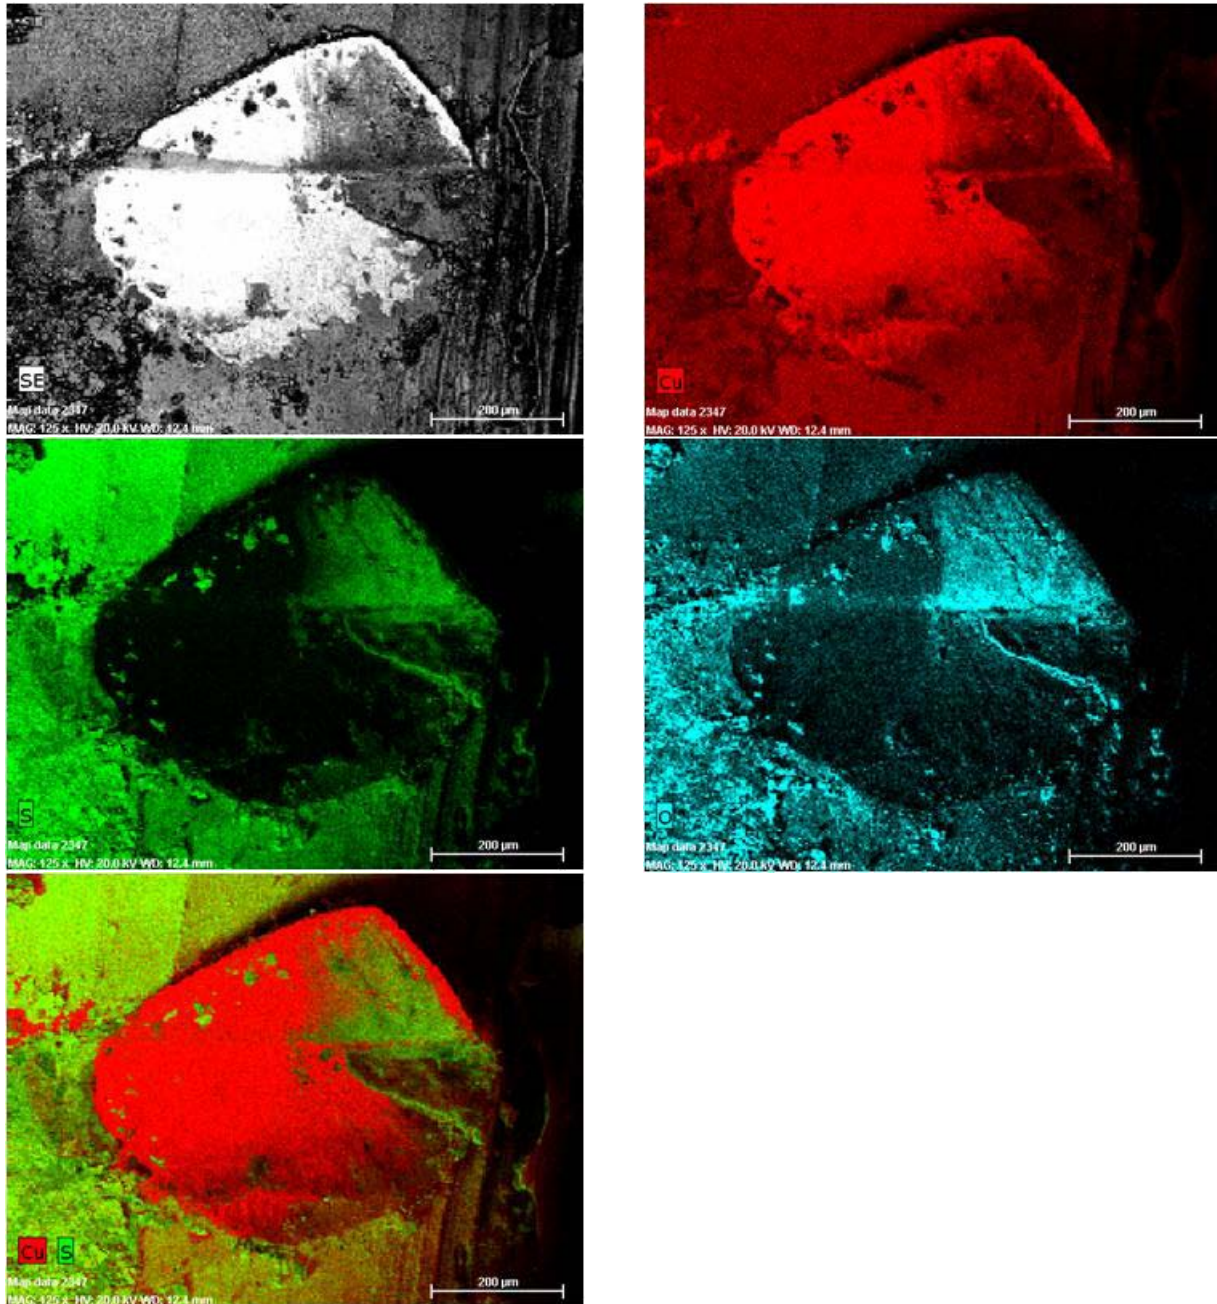
Figure 60 shows the EDS elemental maps from the wire in Figure 59. Copper corrosion products (primarily sulfide with some oxide and/or sulfate) are present on the wire surface, except where the contact was made. In that location, bare copper is visible.

Figure 60. EDS elemental maps of the wire shown in Figure 59. Copper (red), sulfur (green), and oxygen (blue) are shown.

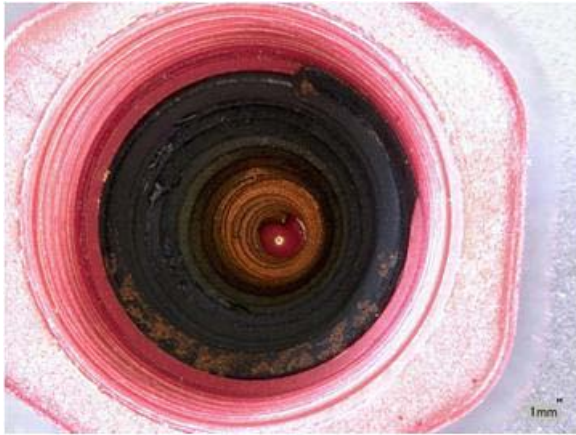
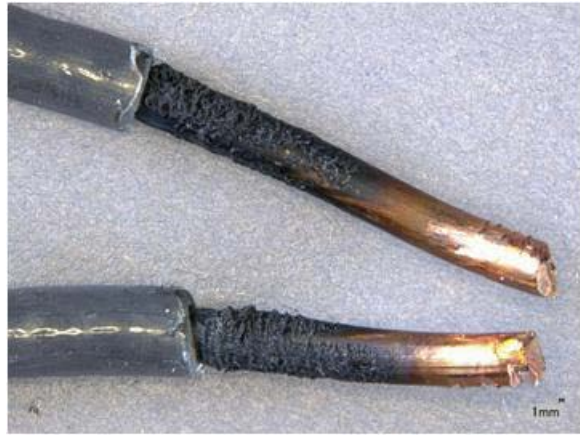
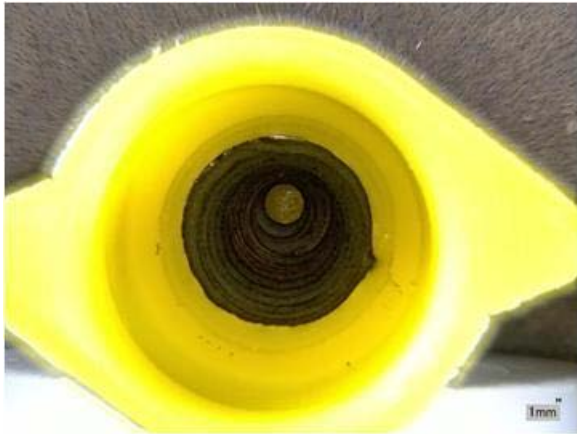
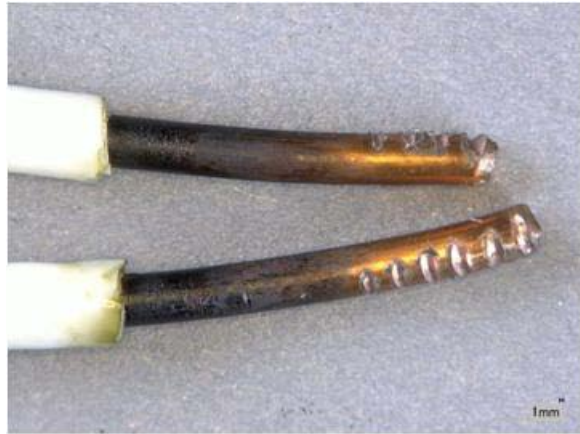
Figure 61 shows optical images of twist-on connectors and the associated wires used to connect component assemblies inside the chamber. Corrosion of both the wires and the twist-on connectors was observed. The extent of corrosion decreased with depth into the twist on connector. A thick corrosion product layer was found next to the insulation. The ends of the wires, where protected by the twist-on connector, exhibit bare copper.

Figure 61. Optical images of twist-on connectors with hot and neutral wires used on the output section of Circuit 2.
